ADVANCEMENTS IN GEOMORPHIC MINE RECLAMATION DESIGN APPROACH, WYOMING ABANDONED MINE LAND, LIONKOL COAL MINING DISTRICT, SWEETWATER COUNTY, WYOMING¹

Harold J. Hutson,² and Robert W. Thoman

Abstract: Following the successful pioneering of Natural Regrade™ technology for geomorphic surface mine reclamation efforts in WY in 2007, the Wyoming AML Division and their Project Engineer, BRS, Inc. of Riverton, WY, applied this surface reclamation approach to the Lionkol Project located near Rock Springs, WY, in Sweetwater County.

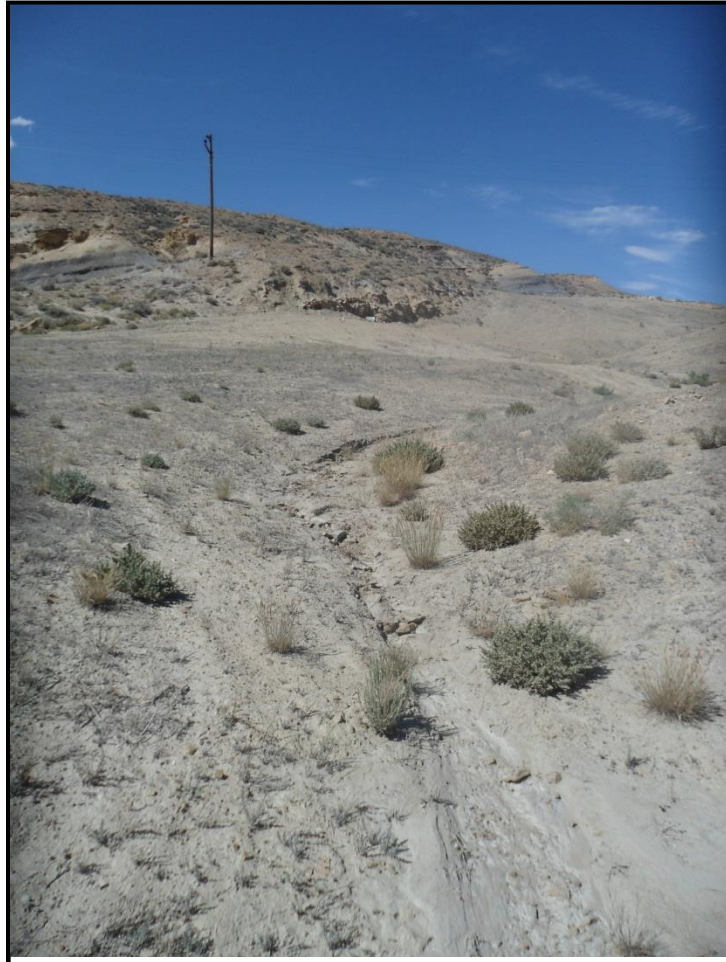
- Vegetation was successfully established in the majority of the armored channels.
- Minimal amounts of coal or other undesirable materials were being exposed and redistributed.
- The performance of the geomorphic channels in Reliance No.11 North is consistent with natural channel behavior shown in Fig. 12, which is the goal of the project.

Figure 12. Reliance No. 11 North channel, looking upstream at a pilot channel forming in the channel bed. The channel is stable.

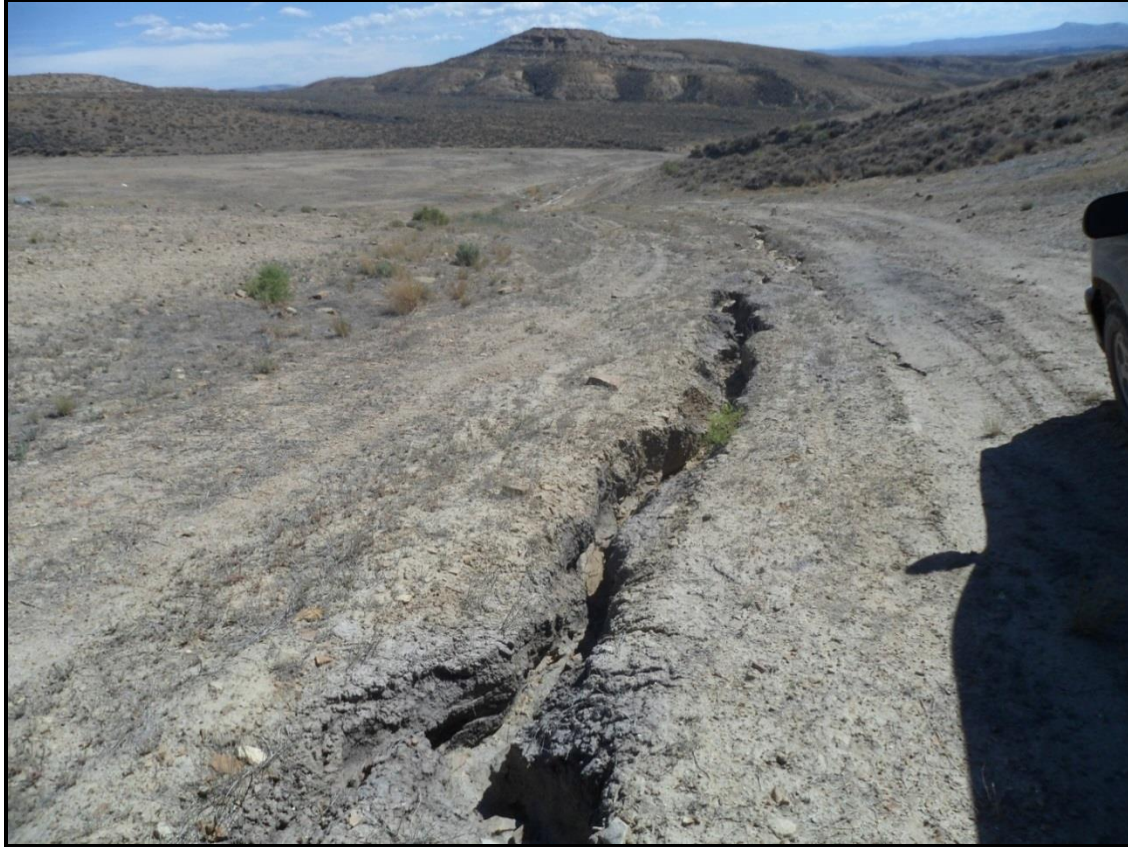
A single failure, requiring repair, occurred within the traditional channels located west of the North Main Pond shown in Fig. 13. Steep channel gradient ($>10\%$) and the 22-ac contributing drainage basin caused failure of the channel, resulting in a 50-ft long by 2 to 2.5-ft deep pilot channel. The failure formed upstream of the confluence between the traditional main channel and its tributary, exposing coal and shale. Erosion diminished and ended in an area of deposition 30 ft downstream of the confluence.

An inspection in the fall of 2016 found the traditional channel in the Reliance No. 11 North Pit had incised again. The traditional channel is mostly straight and needs channel bends to reduce energy. Future repairs to this reach will include redesign with a geomorphic channel configuration.

Figure 13. Traditional channel failure in the Reliance No. 11 North Pit, looking downstream. Steep channel gradient was the cause of the failure.

Repairs were made to the traditional channels in the fall of 2013. Wheel rolling the pilot channel with a scraper was performed to restore a widened channel flow-line and provide compaction. In general, the geomorphic channel provided superior performance compared to the traditional channels in Reliance No. 11 North Basins.

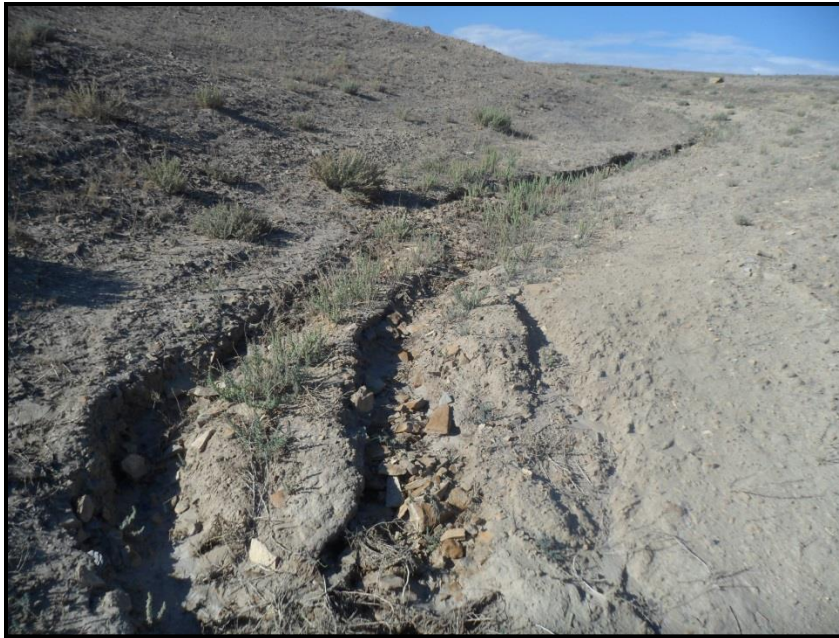
The largest failure requiring repair was along the main channel of the North Spoils, shown in Fig. 14. The channel was incised between 6 and 18 in. along its length, and had several meander bends completely shortcut by pilot channel formation. Following unusually high precipitation in

fall 2013, some of the channels cutting through the meander bends had self-repaired. However, since the channel was designed with high shear stresses and the erosion in the remainder of the channel had not self-corrected, the entire channel needed to be widened to prevent continued flow concentration in the pilot channel. The channel was repaired in fall 2013 to widen and reinforce the channel.

Figure 14. Reliance No. 3 North Spoils main channel failure, cutting through the point bar. The channel was repaired and widened.

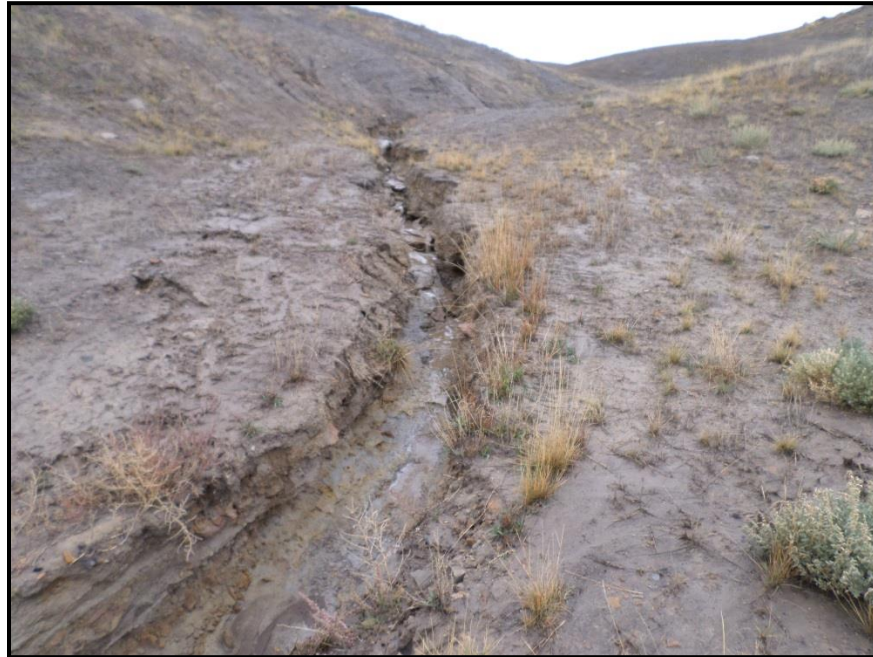
Failures within the main channels were less than 100-ft long and between 12 and 18 in. deep, requiring simple reinforcement repairs. The North Main channel had become completely incised exposing bedrock between 18 and 36 in. below the design grade by fall 2013, as shown in Fig. 15. Although the channel was hard-pointing on bedrock, and would eventually have corrected itself, the process would have required many years and would have resulted in unacceptable amounts of sediment being transported downstream. Therefore, the channel was widened, maintaining the incised grade for the entirety of its length. The increase in cross sectional flow area is expected to reduce the flow energy within the channel and limit unacceptable levels of continued erosion. In addition, the ditch on the south side of the road into which the channel drains, was reinforced.

Figure 15. Lionkol North Main channel failure, incised to bedrock. The channel was repaired by widening the bed and sloping the banks.

To address the poor vegetation and steep slopes in the Lionkol North Main drainage, multiple pockets or depressions were cut in rilled areas. The depressions were 8-ft wide by approximately 20-ft long and 1- to 2-ft deep. The depressions trapped water, reducing further erosion, and provided a water source for vegetation growth. Inspections in 2015 and 2016 noted improved vegetation growth in the depression areas. However, the eventual siltation of the depressions

caused little water to be retained. Additional depressions were constructed in between the existing depressions in fall 2015. In the Lionkol Lower Spoils and Lower Pit, areas with poor vegetation growth were amended with manure and reseeded in 2013. An inspection in fall 2016 noted improved vegetation growth with minimal erosion. Minor channel work was completed at the outlet to the Lionkol Main channel in connection with work completed in the Lionkol Main drainage in 2016.

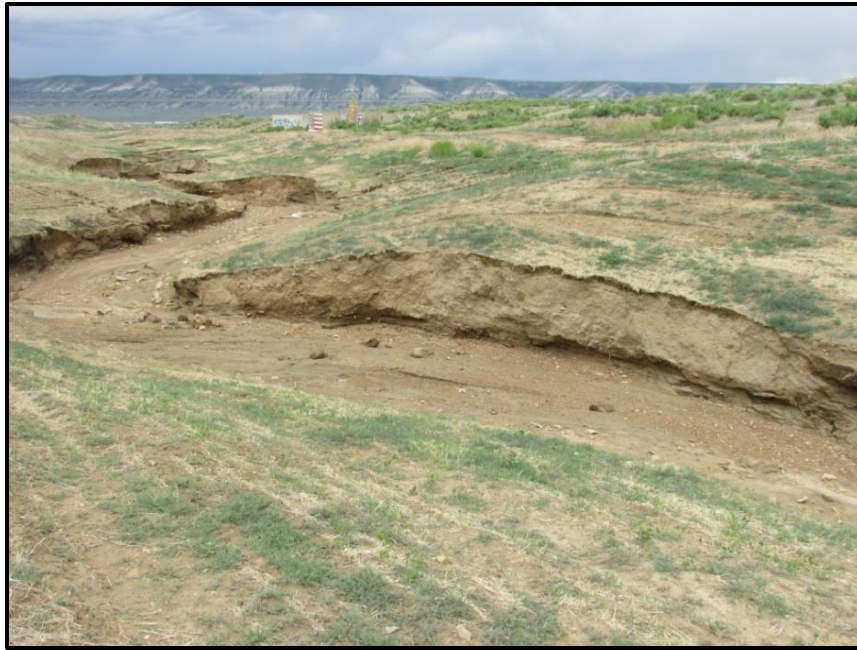
Storm flows in the Lionkol drainage in the spring and summer of 2016 surpassed those of the previous years. The Lionkol Stock Reservoir, designed to contain the 100-year storm volume, filled, and the spillway conveyed excess flows. The main channel sustained damage that required repairs, as shown in Fig. 16. Repairs were performed in fall 2016 and included a re-design of the channel where the Upper and Lower drainages meet (Fig. 7). This is an area where two design

Figure 16. Channel bank cutting in 2016 at the confluence of the Lionkol Upper and Lower drainage. Repairs were made through a re-design of this section.

channels converged to avoid historic structures. The discontinuity in the channel slopes at this confluence created channel instability. The re-design smoothed the slope transition over approximately 300 ft of channel. Instead of filling the channel by sloping the banks as was completed previously, the channel bed was left at its elevation and width. The channel banks were sloped back, and the excess material was used to reinforce the toes of the meander bends as shown in Fig. 17. The channel width increased from the NR design width of approximately 2.5 ft to the existing width of 6 to 8 ft. Approximately half of the channel length required repairs.

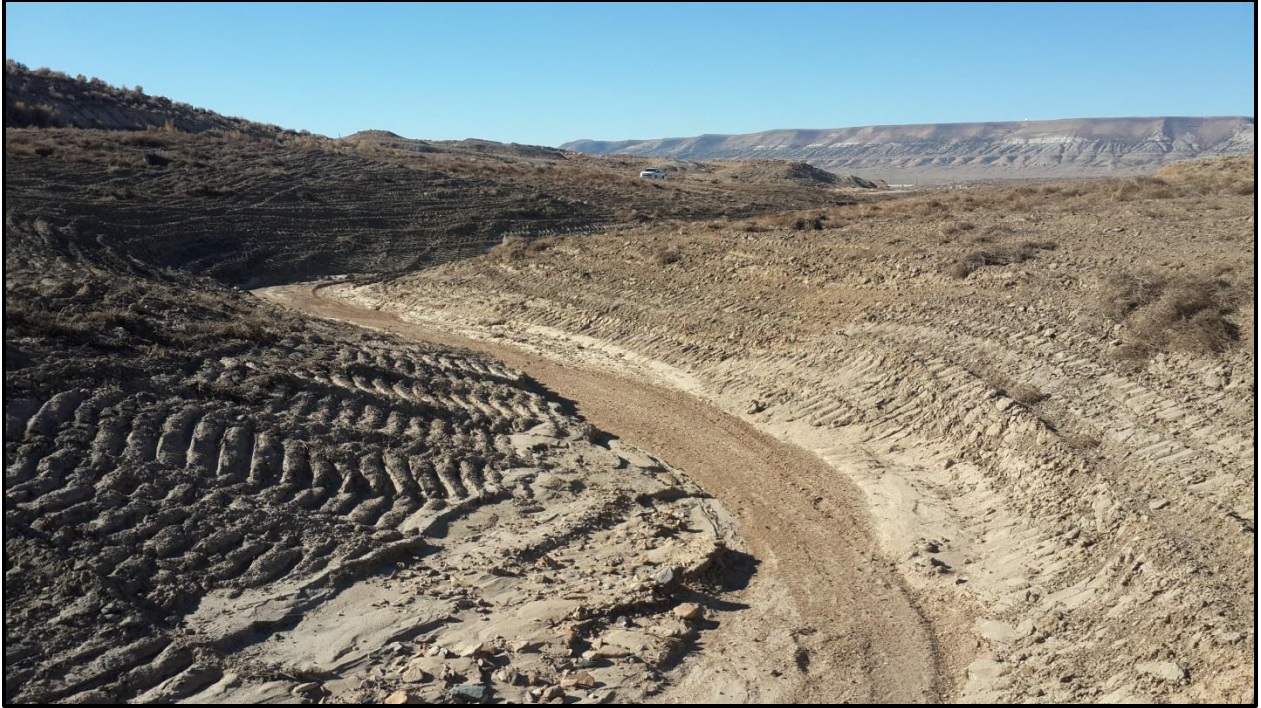
Figure 17. The regraded main channel of the Lionkol drainage after repairs in fall 2016. A storm event tested the channel shortly after the repairs were made.

Due to the series of years with above-average precipitation, a retention structure was added to restrict the flows in the main channel. This was accomplished by building an embankment over a road crossing upstream of the project and restricting the flow to a single 48-in culvert, roughly equivalent to the 50-year runoff. In addition, four rock structures along the Lionkol drainage required minor repairs.

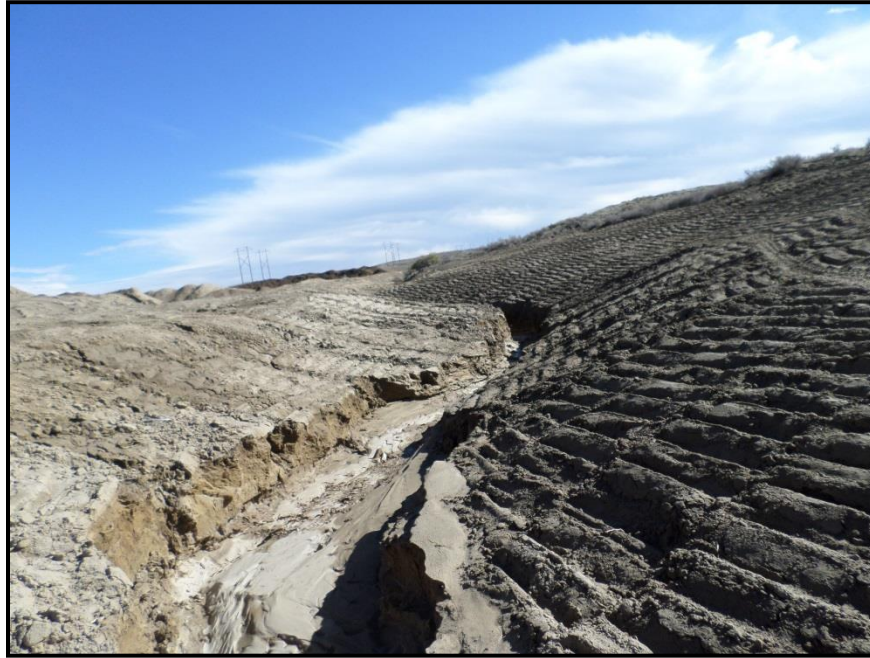
During construction, Lionkol West experienced three separate heavy storm flows, with a return interval of between a 10-year and 25-year storm. The flow during these events was up to 3 ft deep in the main channel and cut into the banks in one location up to 2 ft deep, as shown in Fig. 18. Erosion damage from the storm required the contractor to refinish sections of the channel. The storms provided a real-world test of the various channels while an engineer was onsite to observe. Because the multiple storm events were of similar magnitudes (0.23 to 0.5 in. per 24 hours), it was

Figure 18. Lionkol West, Upper Reach. Channel erosion from storm events during construction.

Smaller repairs in the channels consisted primarily of collapsing cut banks and widening the channel bottom. A large head-cut in the upper portion of the main channel was repaired by replacing the eroded material to maintain a stable grade. Below the box culvert, a concrete apron was constructed to protect the channel, and a rock structure was installed at the end of the apron to dissipate the energy from the flow.

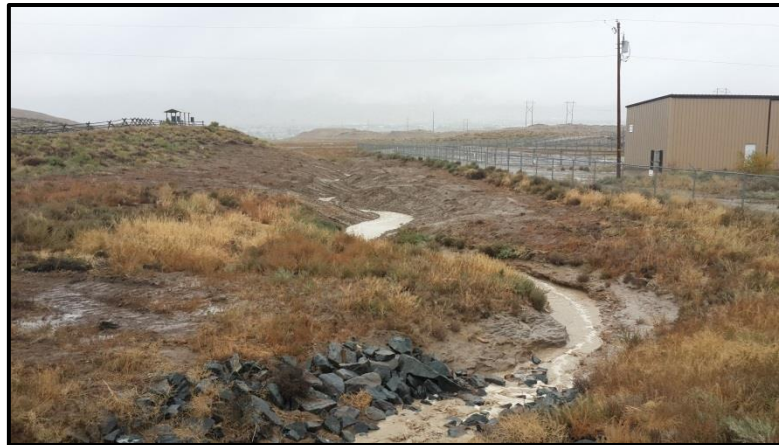
Channel inspections were conducted in fall 2015 and 2016. Minor channel repairs were made in fall 2015, mostly to repair rock structures. In 2016, repairs were made to the Central Reach next to the BLM Horse Corrals. The same approach was used to leave the channel bed at its current elevation and width, and slope the banks back. This provided a wider channel than the NR-based design and helped reduce flow depth and subsequent shear forces. Figure 19 shows the channel during a storm event, after repairs were made.

Figure 19. Lionkol West, Central Reach. Stormflows were observed after repairs were made in 2016.
