# RESTORING WOODY PLANTS ON A CONSTRUCTED STREAM CHANNEL AT A HIGH ELEVATION ABANDONED MINE IN IDAHO

American Society of Mining and Reclamation  
National Meeting, Oklahoma City, June 2014

# Project Background

# Project Scope

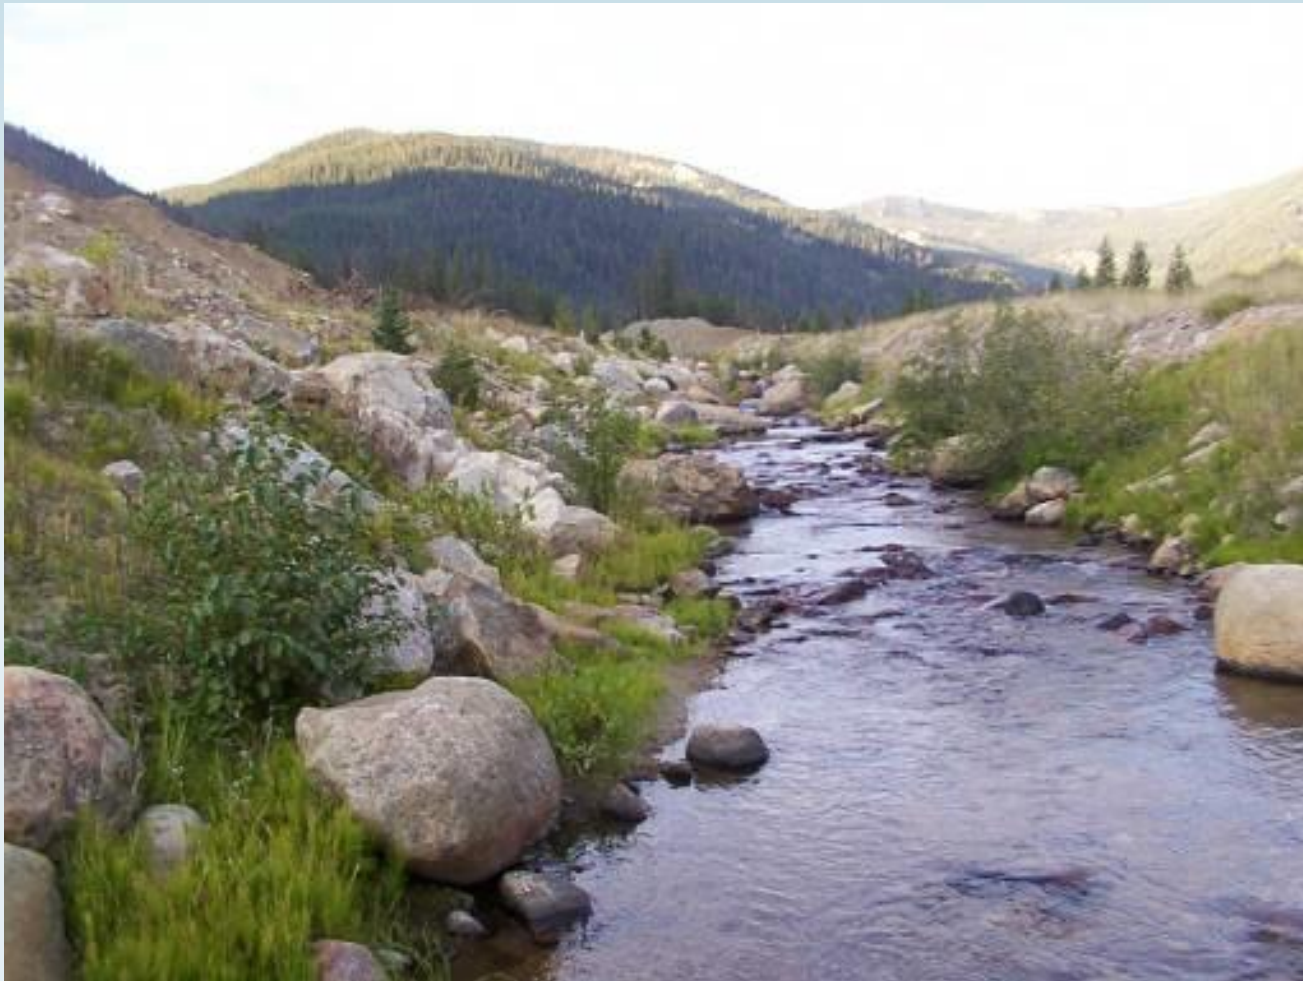
# Channelized Meadow Creek

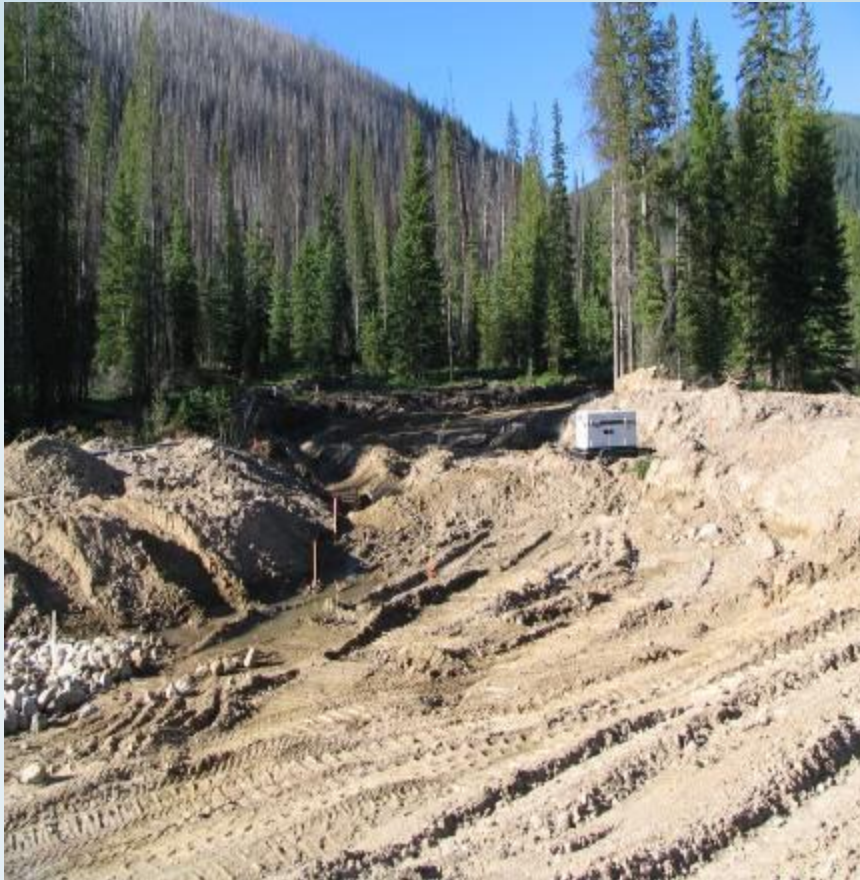
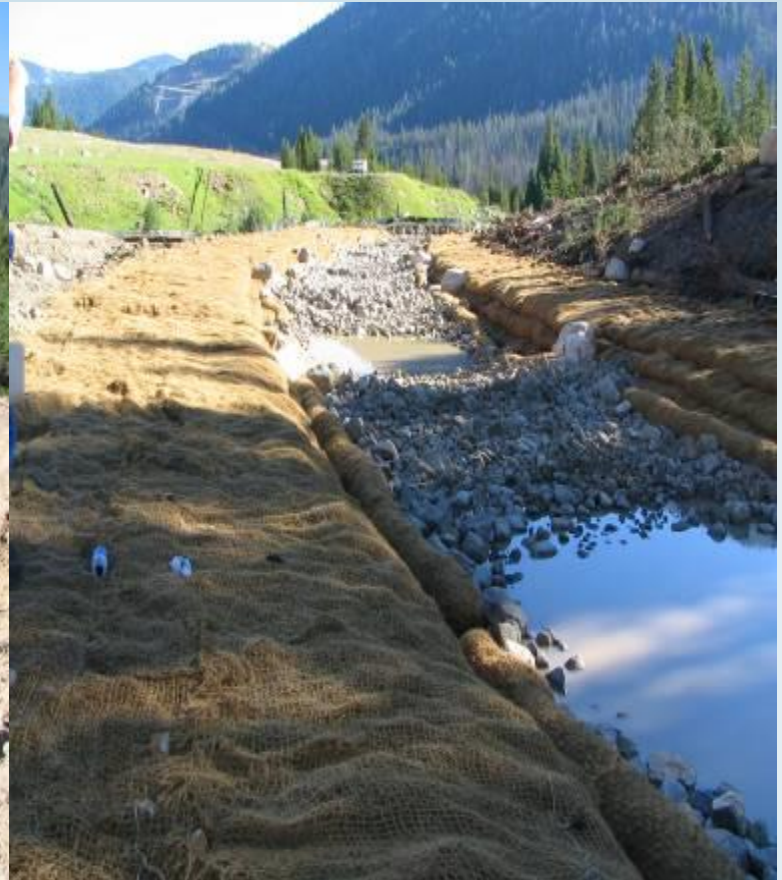
# New Meadow Creek Channel Construction

- New channel constructed in part of flood plain not impacted by tailings
- Revegetation work completed in September 2005
- Meadow Creek routed into new channel
- Stranded fish rescued and relocated to new channel
- Old channel backfilled and revegetated

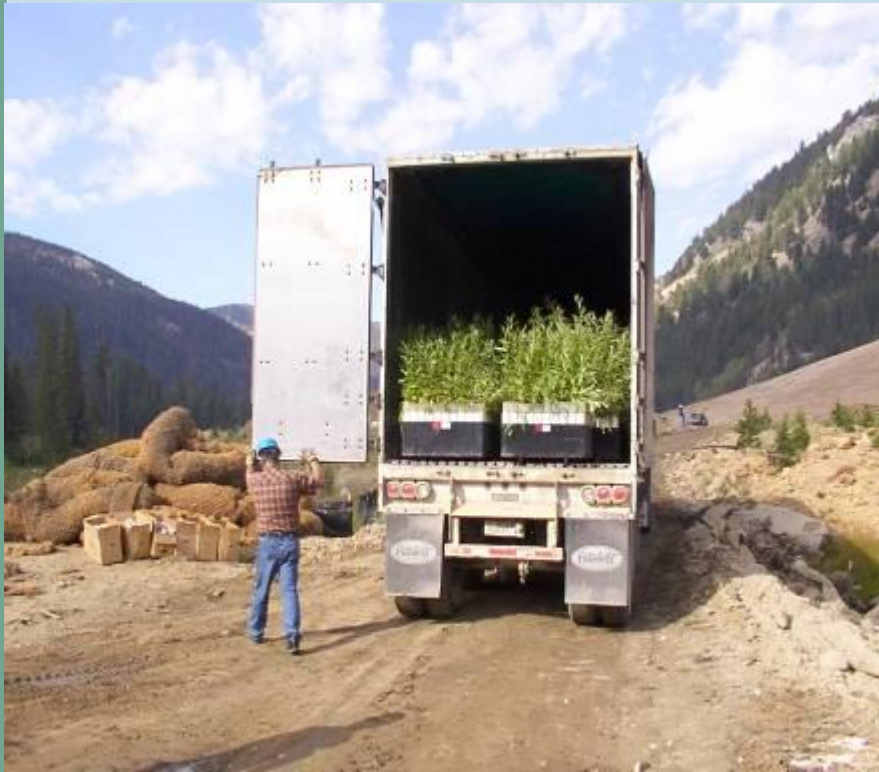
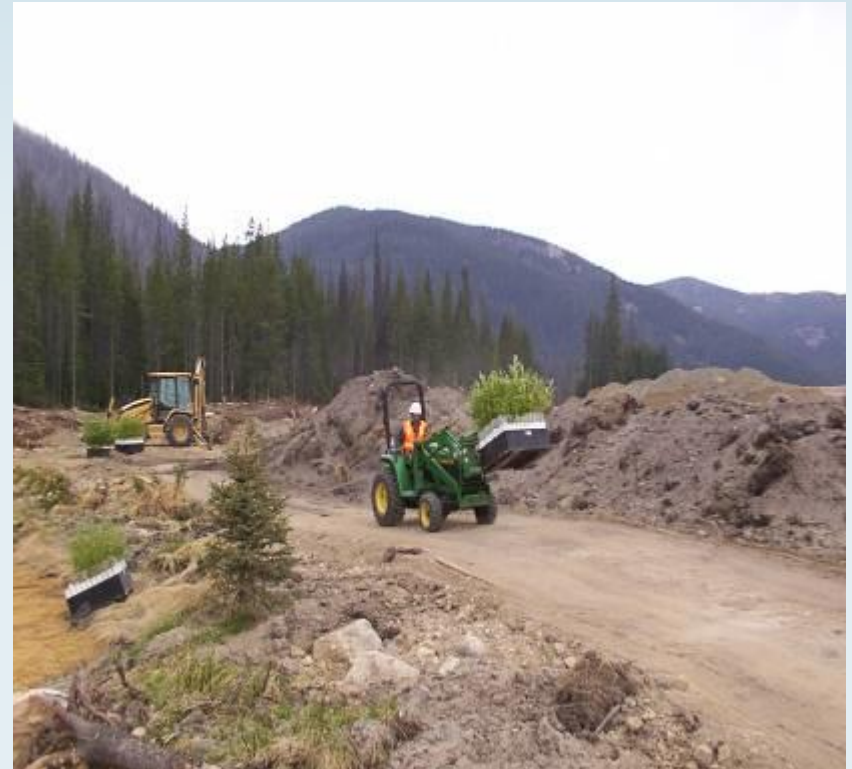
- Willow plants
  - Local cuttings grown in containers 3 by 14 inch
- Willow cuttings
  - 4 feet by ½ inch collected on site
- Willow clumps
  - Salvaged on site
  - Planted on erodible outside stream bends

# Willow Plants

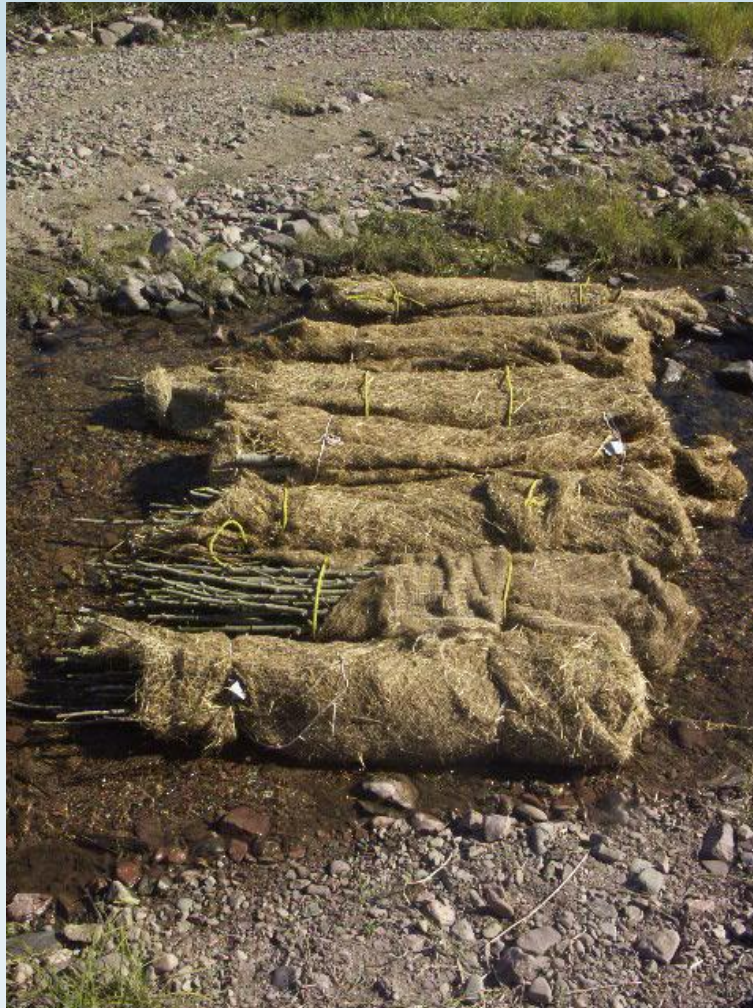
# Cuttings

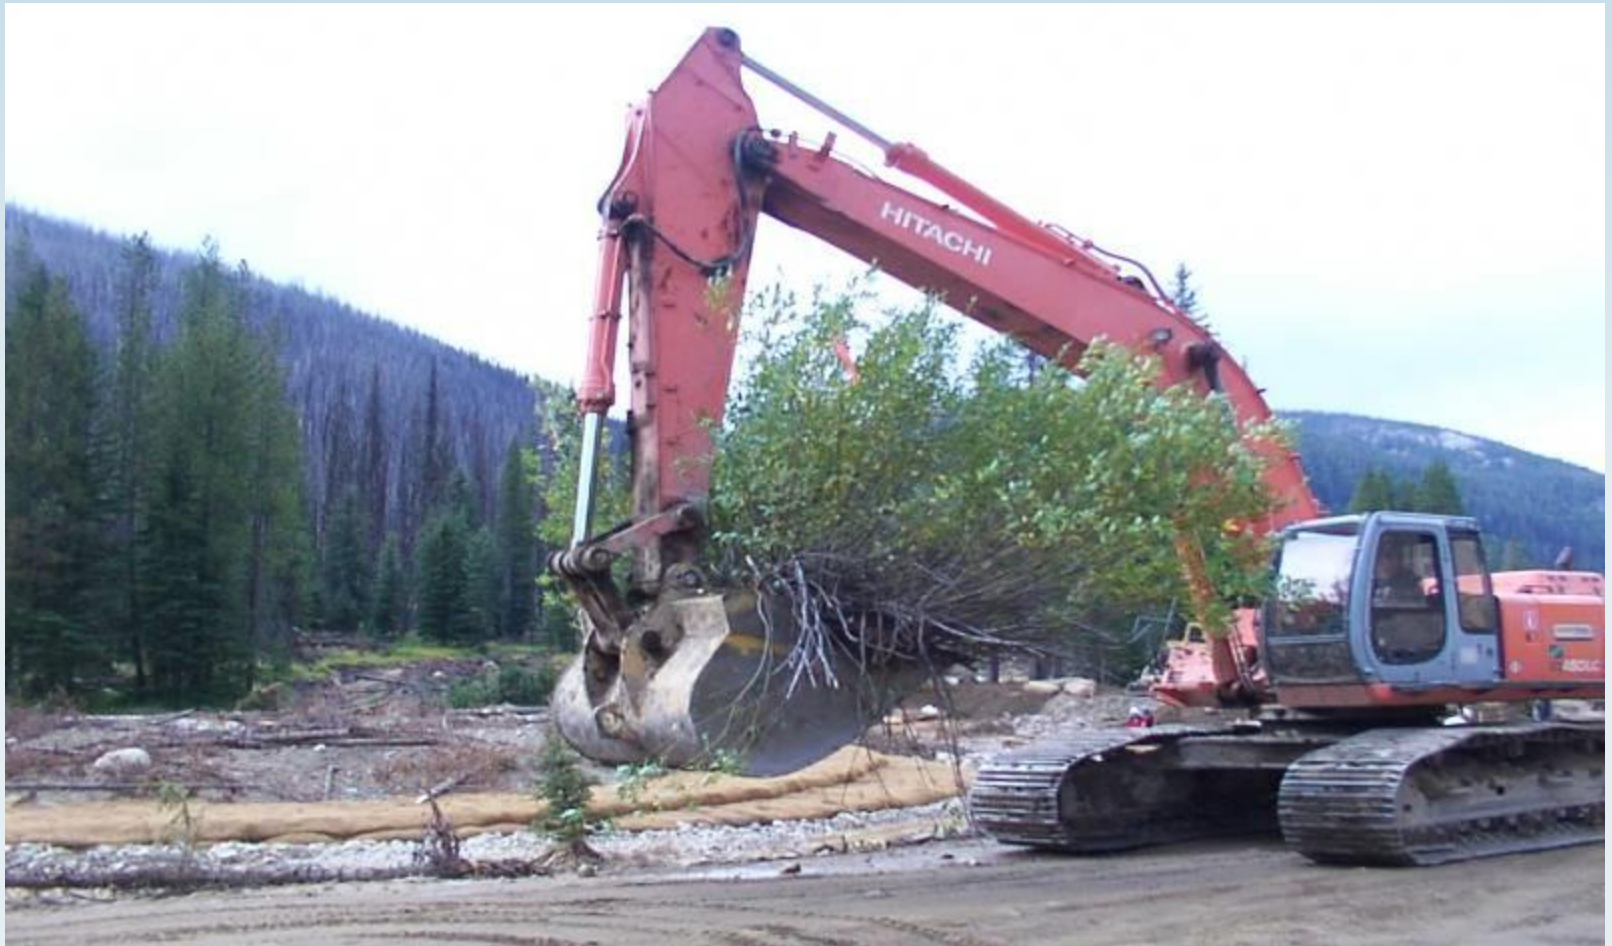
# Willow Clumps

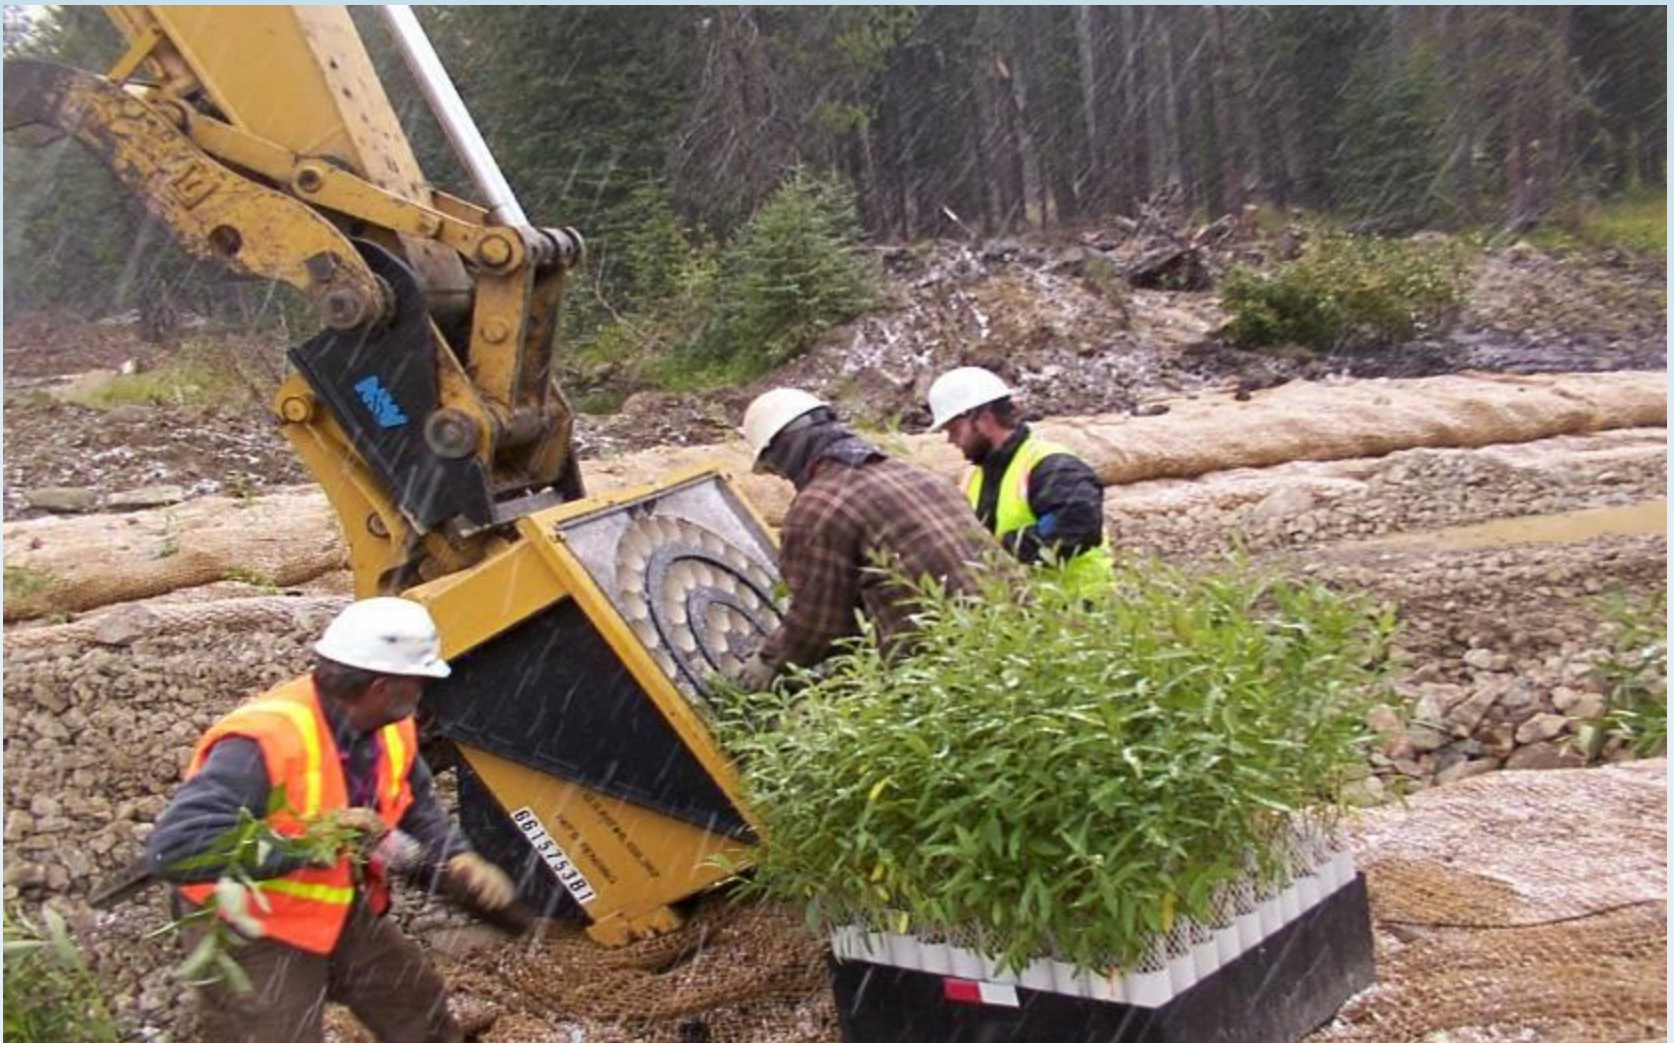
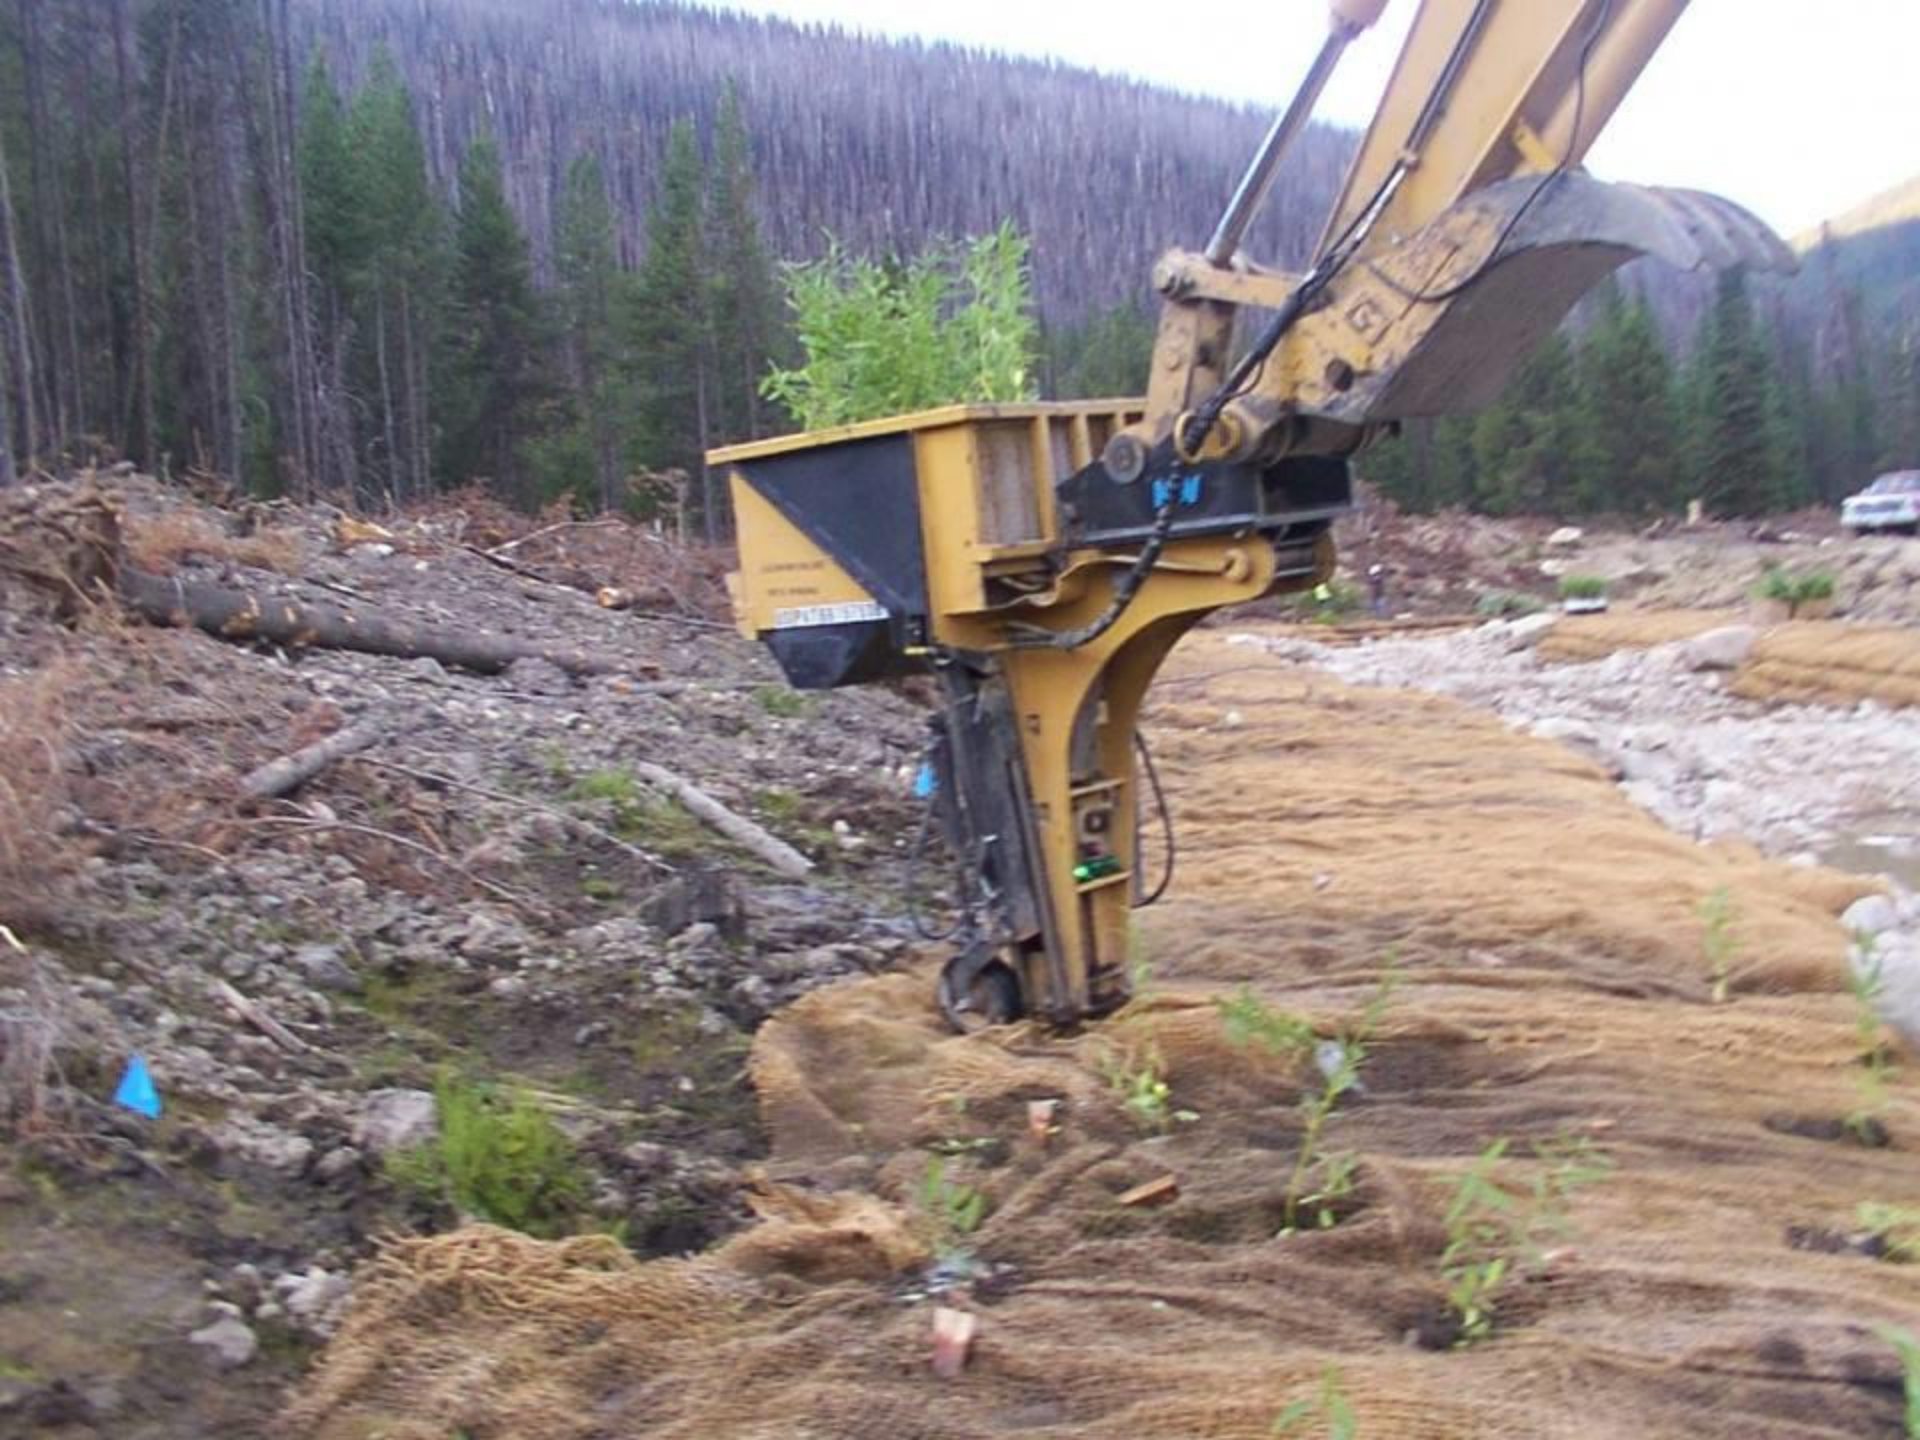
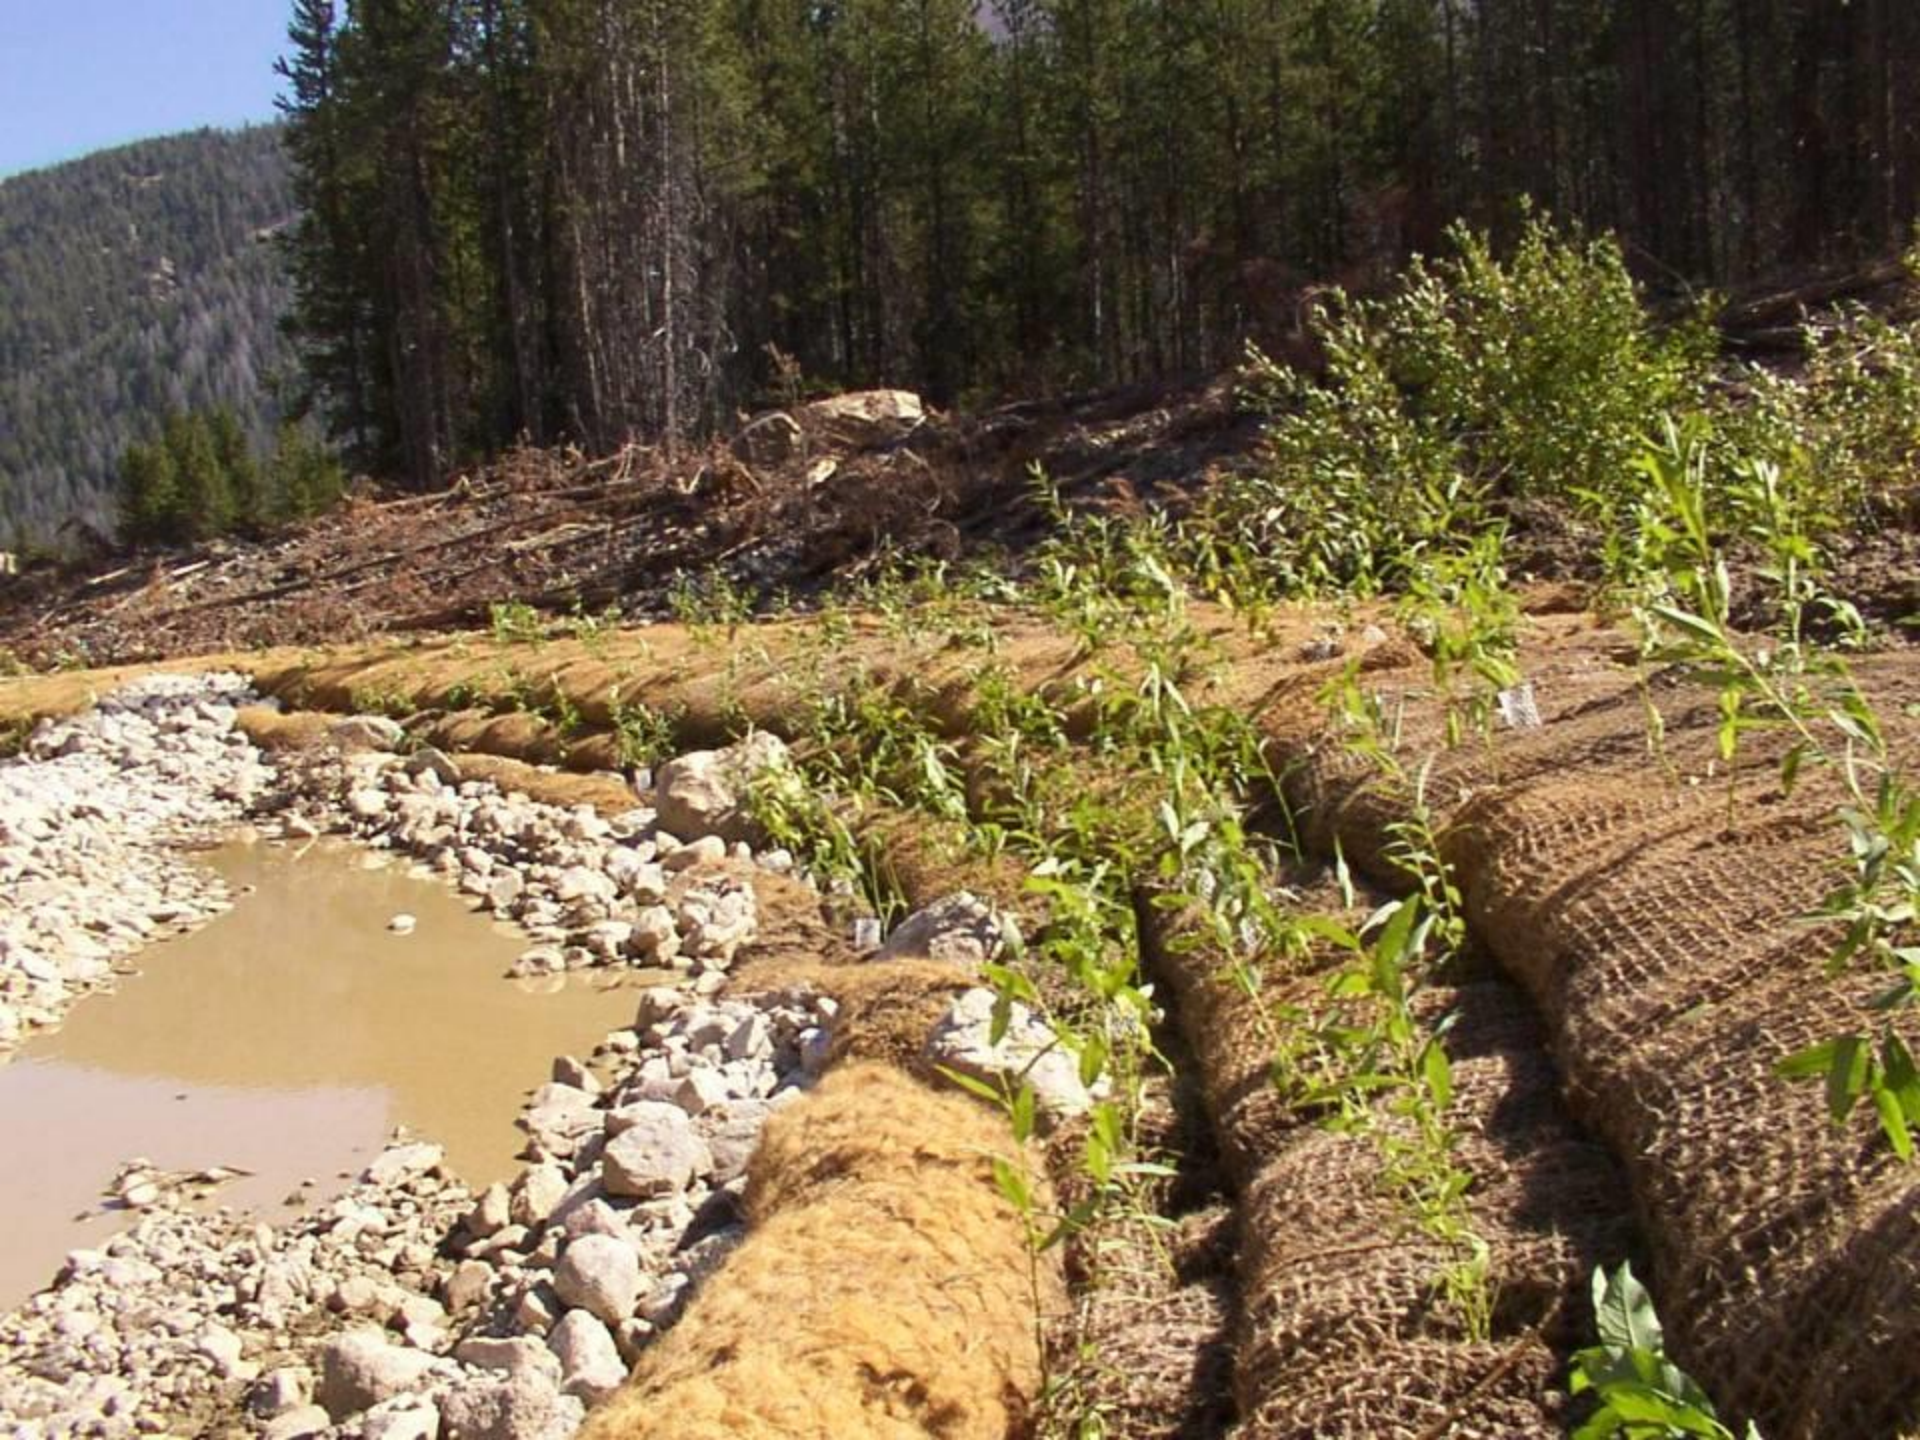
# Container Willow Planting

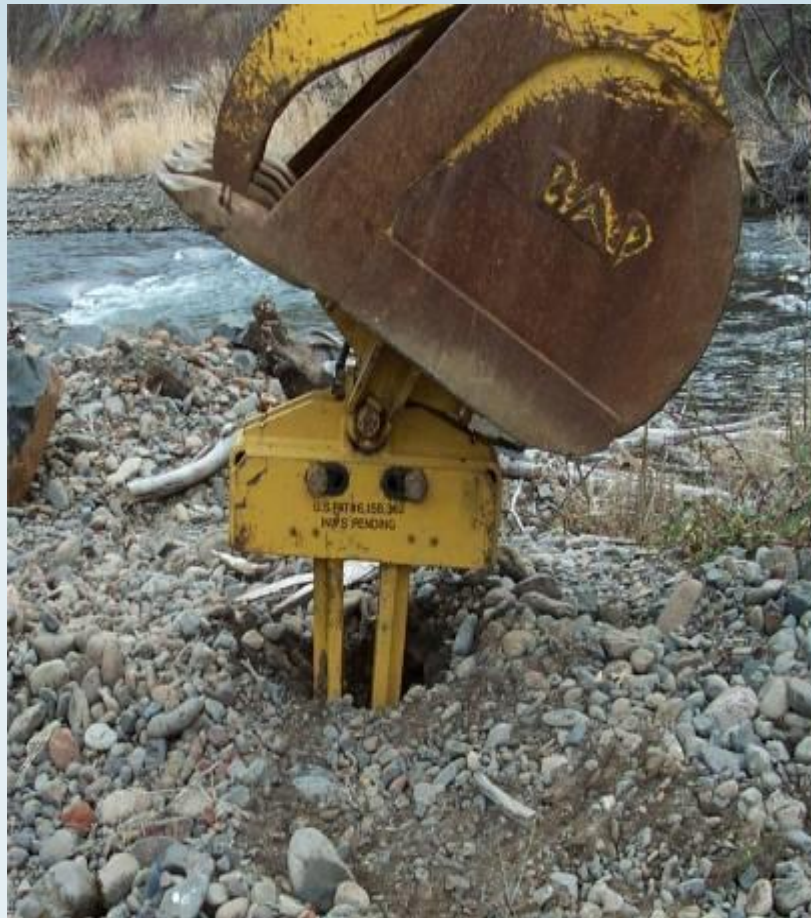
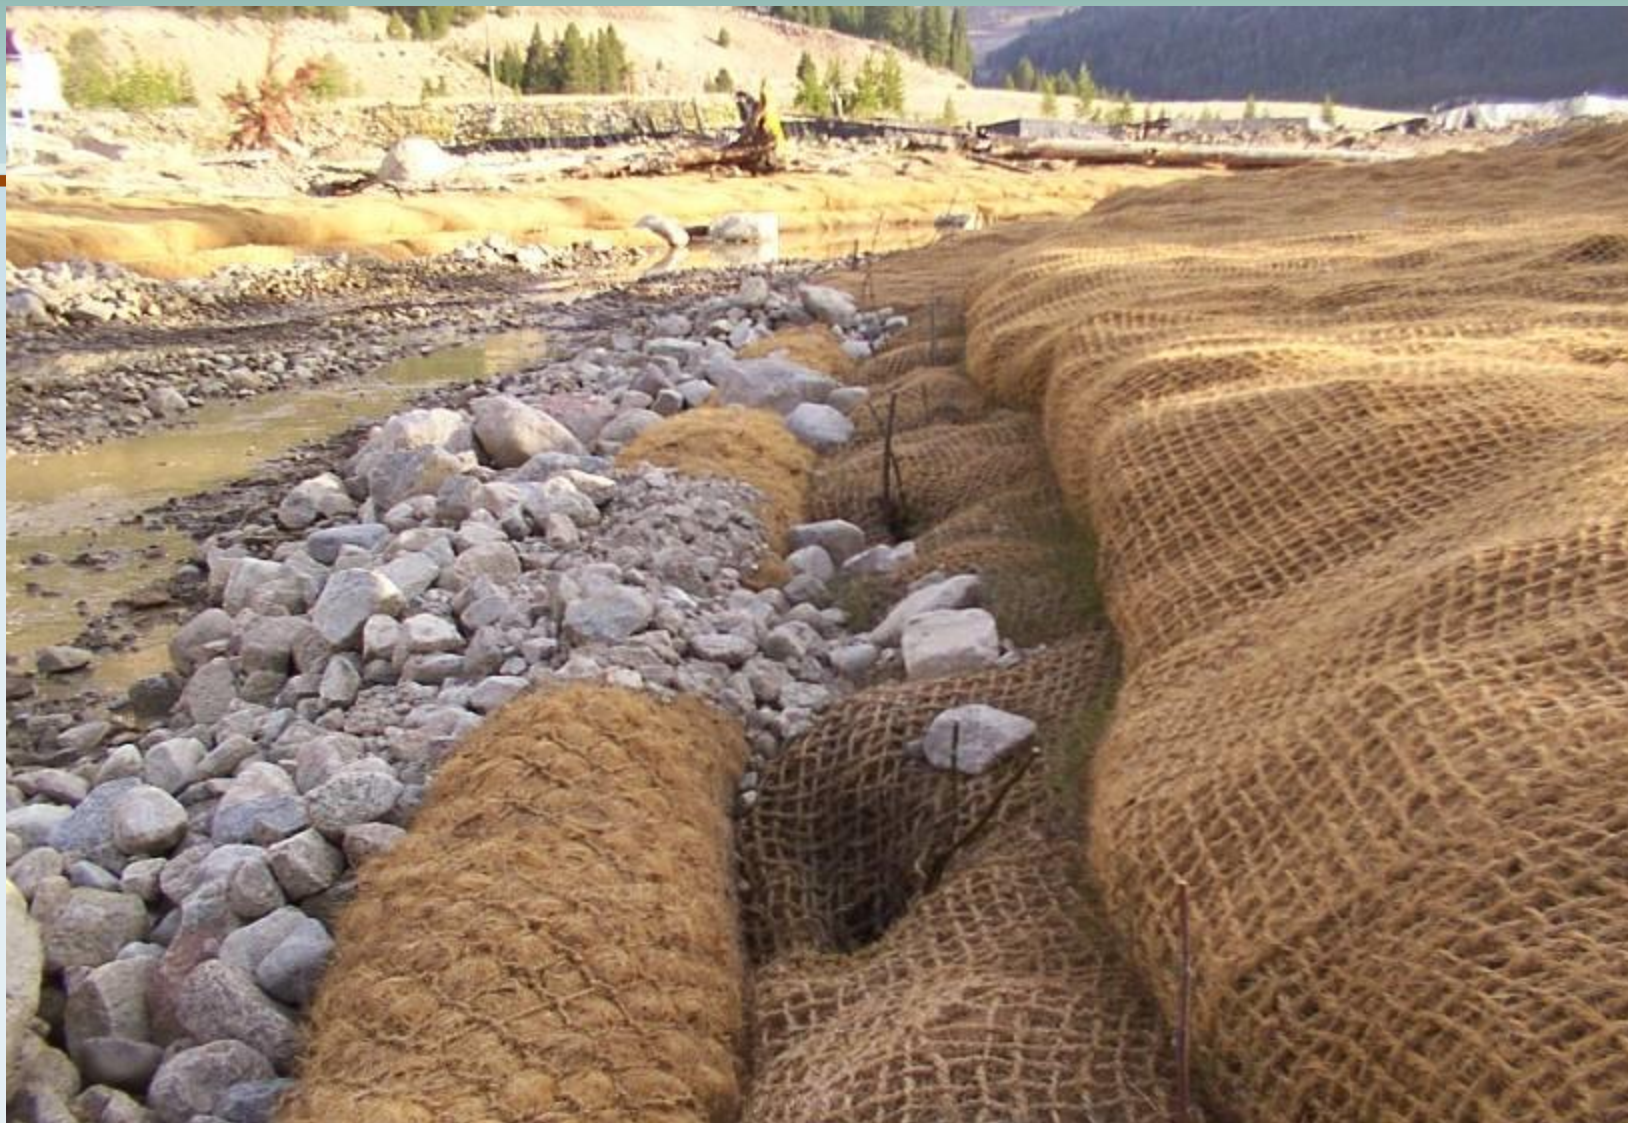
# Willow Cutting Installation

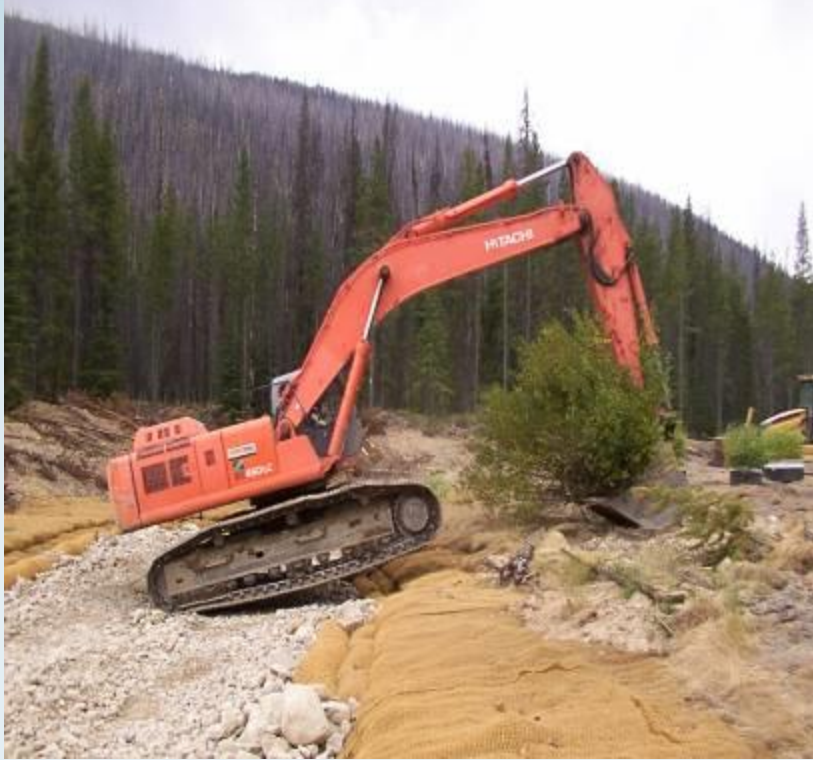
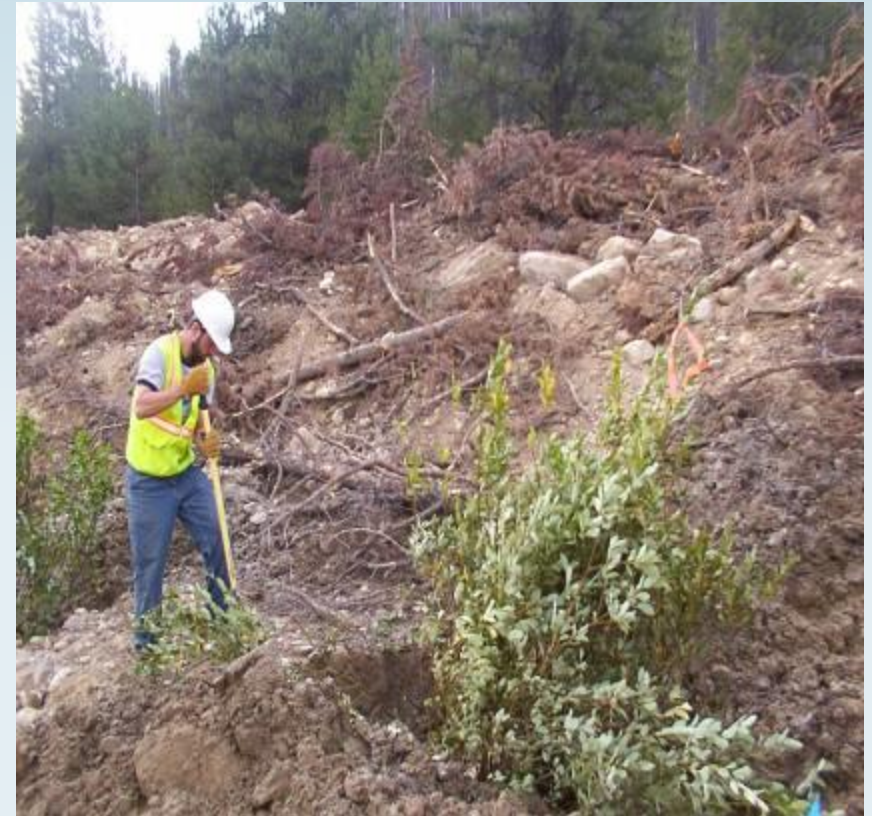
# Planting Willow Clumps

- Salvaged willow clumps
  - 70% survival
  - Dormant salvage and trimming would have improved survival
- Wolves in the area preventing browse damage
- Fish and macro invertebrate populations were starting to recover
- Recreational fishing was occurring on the restored reach of Meadow Creek

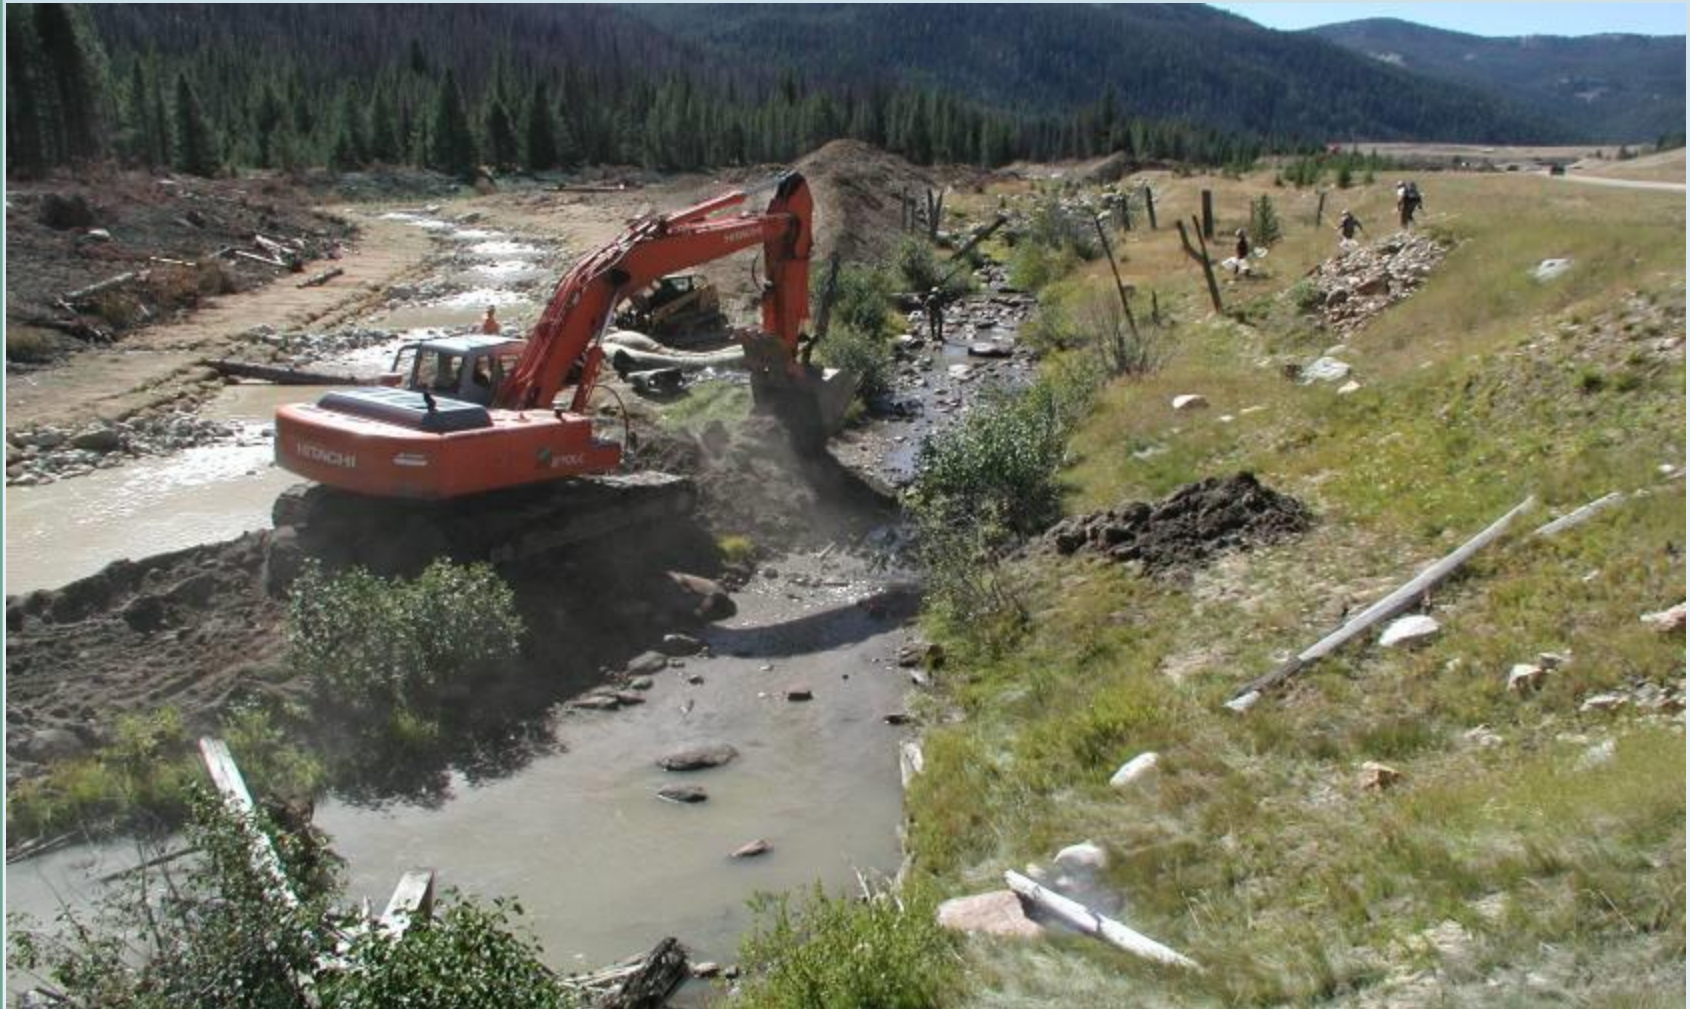
# Filling Abandoned Channel

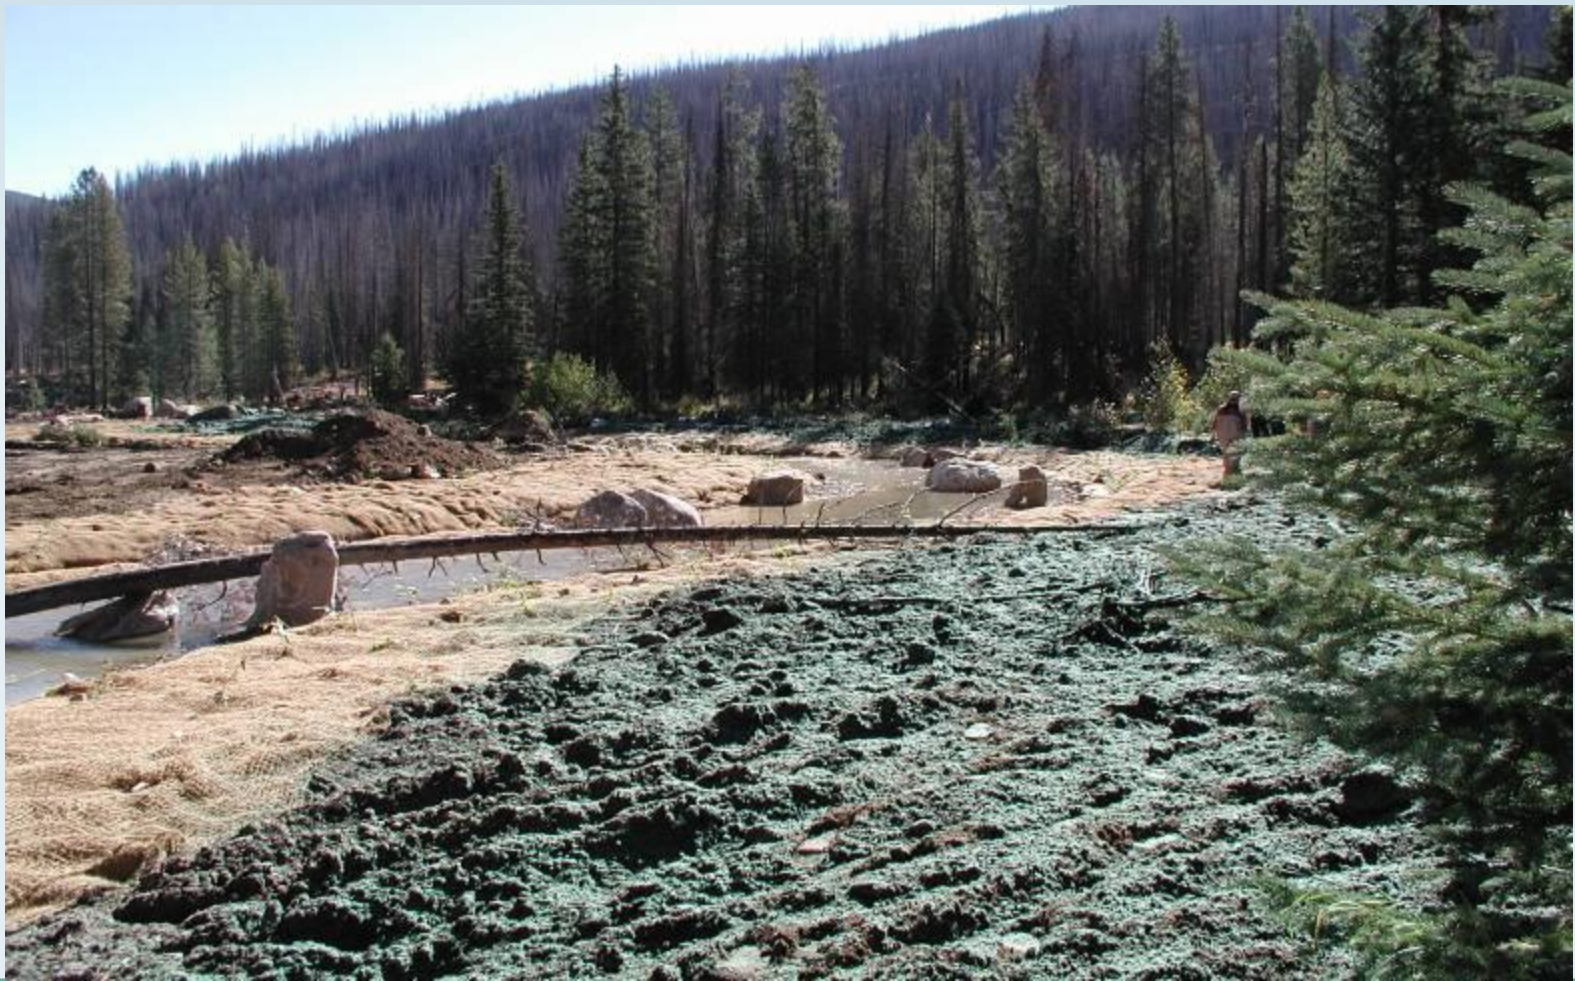
# New Channel Background Old Channel Filled and Seeded Foreground

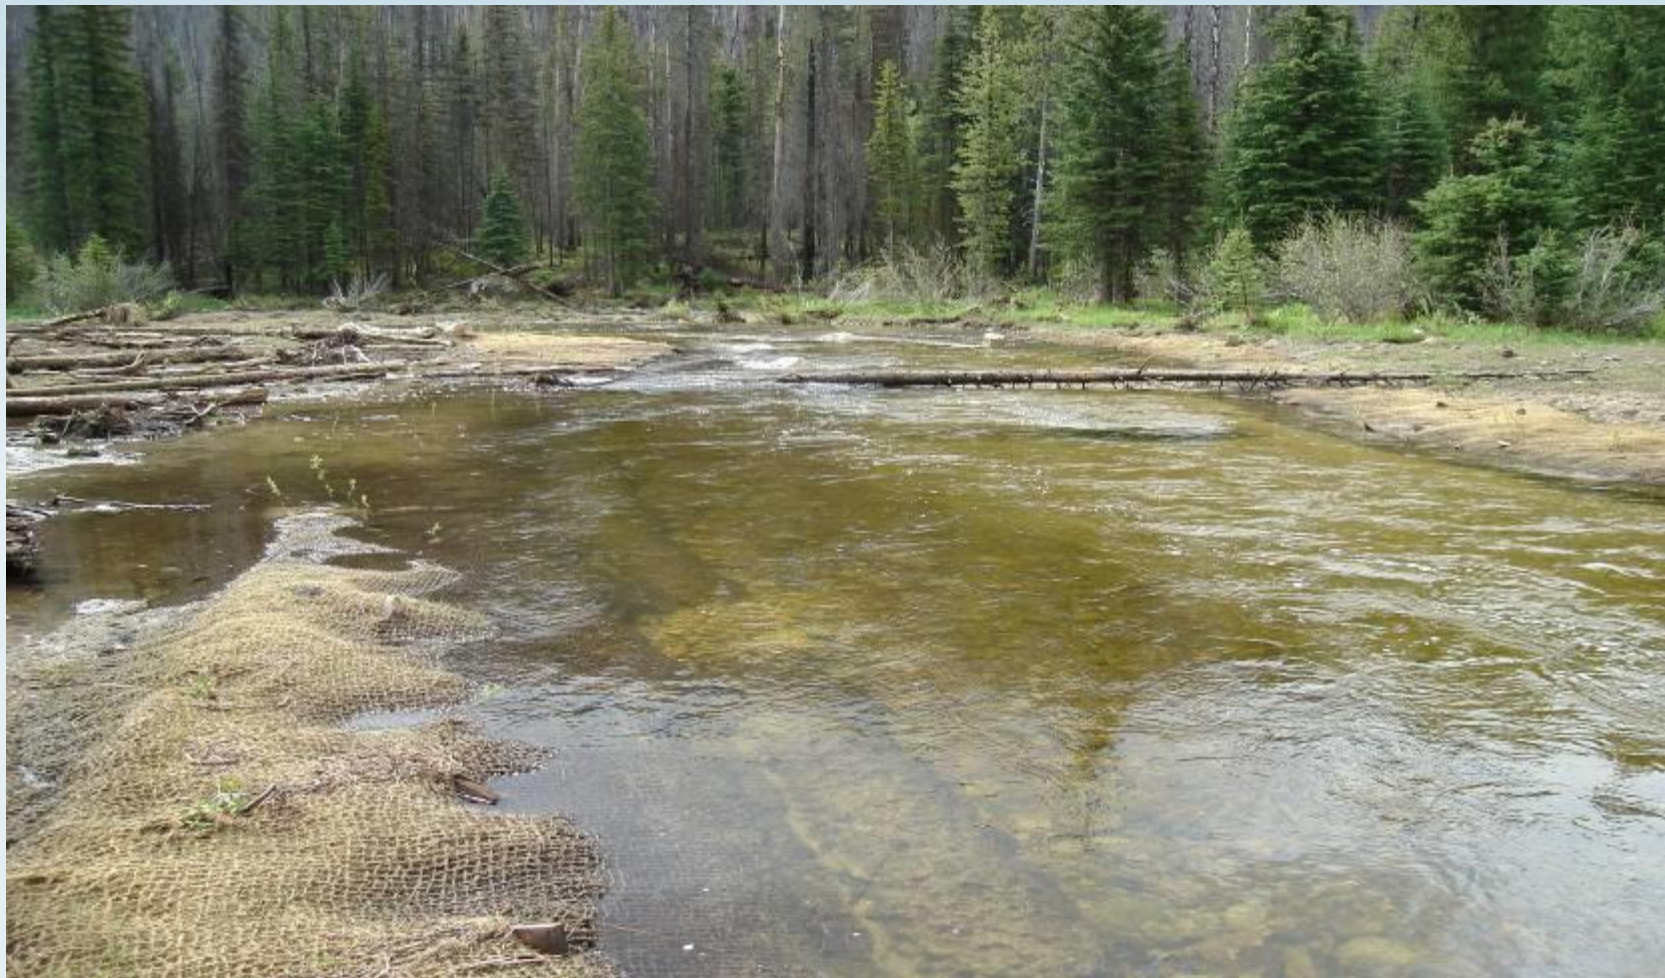
# June 2006

## Inundation for over a month
