# RESTORING WOODY PLANTS ON A CONSTRUCTED STREAM CHANNEL AT A HIGH ELEVATION ABANDONED MINE IN IDAHO

American Society of Mining and Reclamation  
National Meeting, Oklahoma City, June 2014

# Project Background

# Project Scope

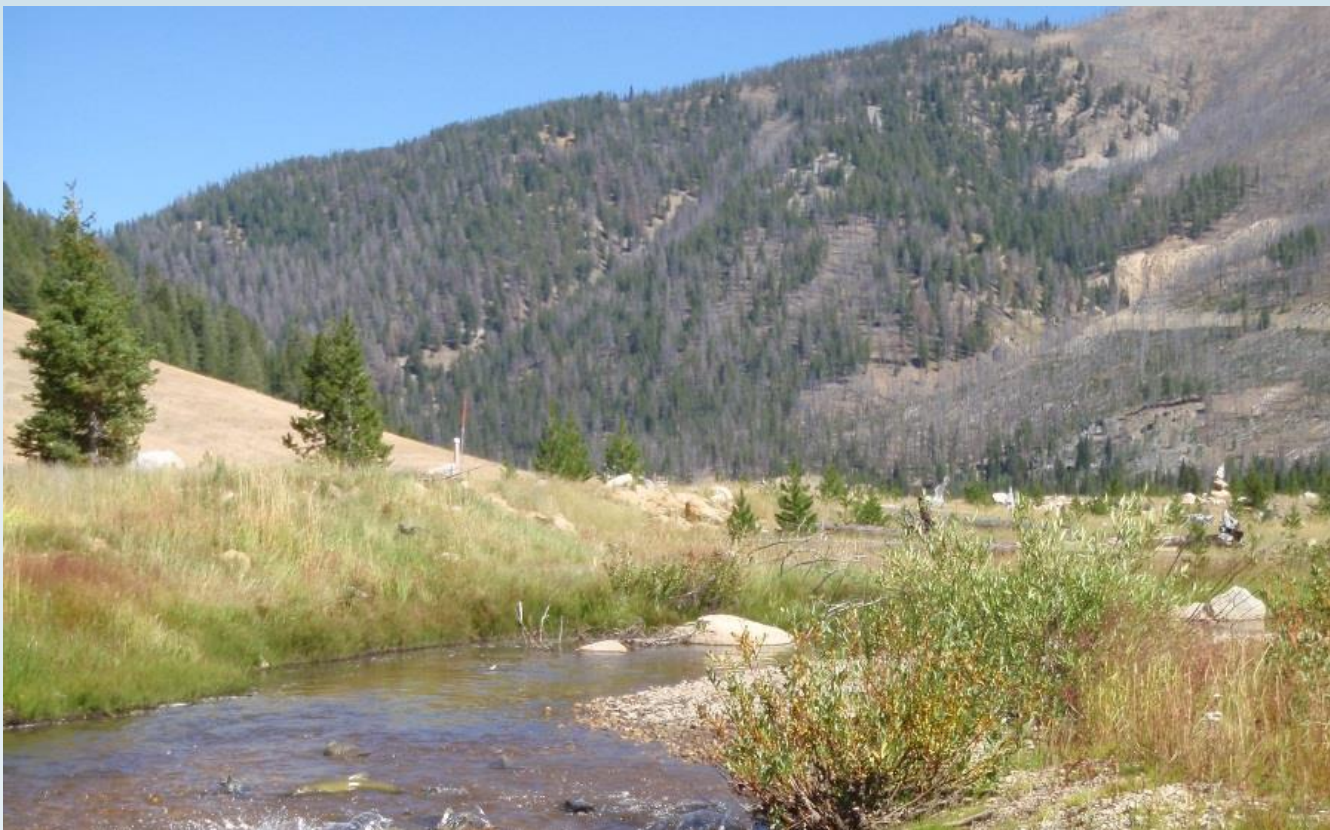
# 2013

- The Willows are maturing and spreading
- An excellent fishery with Bulltrout and West Slope Cutthroat trout has developed
- A large landslide in a tributary to Meadow Creek occurred in 2012 resulting in a large flush of sediment and heavy flows. The stream banks handled the heavy flows with minimal impact.
