Advanced Planning and Measurable Outcomes: Restoration Success in Southern Colorado

Colorado Springs Utilities Southern Delivery System Pipeline Work Packages S1, S2 and S3

Western States Reclamation, Inc.

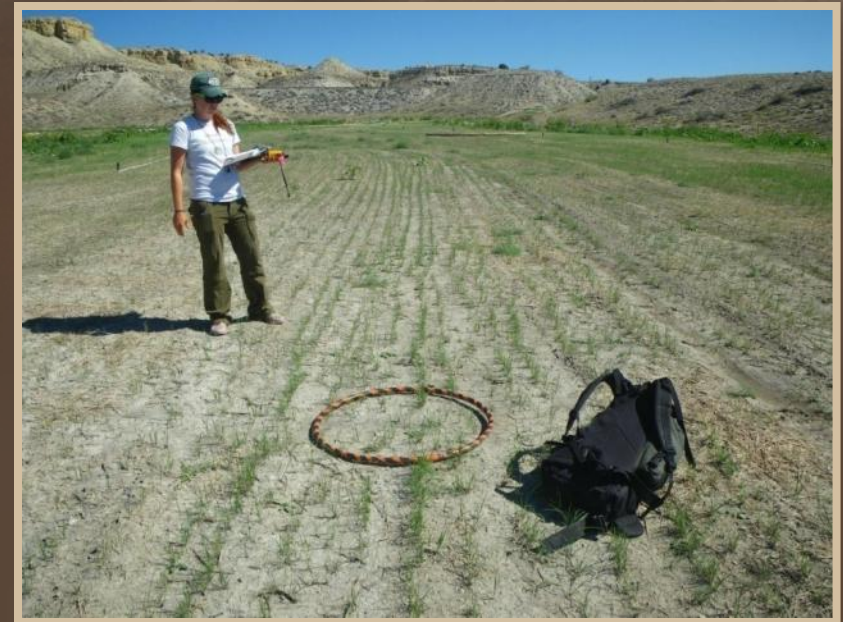
In late summer of the first and second growing seasons, quantitative measurement of cover and species diversity/richness were made at more than 165 randomly selected locations. At each random sample point, sampling of cover was accomplished along randomly oriented 50 m transects using point-intercept methods (see details at <http://www.esco-associates.com/ESCOfdatacollection.htm>). Frequency plots (ten 1m x 1m evenly spaced along the 50 m transects) were used in determining the presence and distribution of desirable plant species.

In late summer of the first and second growing seasons, quantitative measurement of cover and species diversity/richness were made at more than 165 randomly selected locations. At each random sample point, sampling of cover was accomplished along randomly oriented 50 m transects using point-intercept methods (see details at <http://www.esco-associates.com/ESCOdatacollection.htm>).

Frequency plots (ten 1m x 1m evenly spaced along the 50 m transects) were used in determining the presence and distribution of desirable plant species.
