ADVANCEMENTS IN GEOMORPHIC MINE RECLAMATION DESIGN APPROACH, WYOMING ABANDONED MINE LAND, LIONKOL COAL MINING DISTRICT, SWEETWATER COUNTY, WYOMING¹

Harold J. Hutson,² and Robert W. Thoman

Abstract: Following the successful pioneering of Natural Regrade™ technology for geomorphic surface mine reclamation efforts in WY in 2007, the Wyoming AML Division and their Project Engineer, BRS, Inc. of Riverton, WY, applied this surface reclamation approach to the Lionkol Project located near Rock Springs, WY, in Sweetwater County.

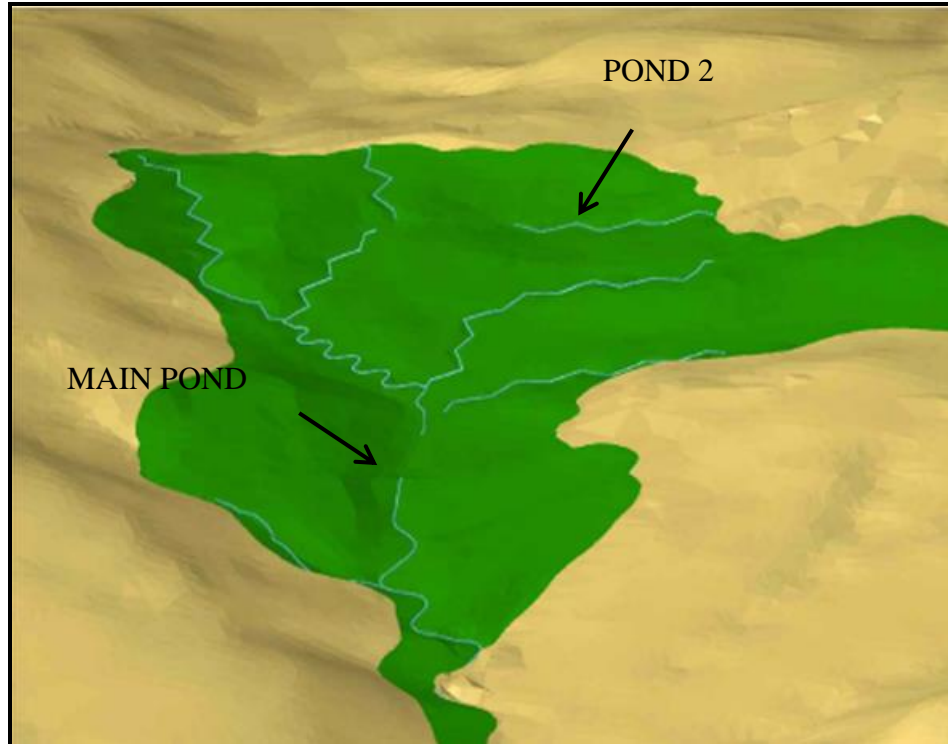
Two surface-water impoundments were constructed on the Reliance No. 11 North site, as shown in Fig. 2. Both impoundments provide runoff attenuation to downstream reaches. Pond 2 does not discharge and the Main Pond provides peak flow attenuation with a lag time of approximately 30 minutes. Two riprap-erosion-control drop structures were installed on the North Pit outlet channel to compensate for the vertical differential between spoils in the disturbed mine site and the native outlet channel. For this channel portion, a traditional 12-ft flat bottom channel was constructed with a meandering alignment for a smooth transition into the drop structures. In addition, a riprap-grade-control structure was installed at the outlet of each of the impoundments to protect the impoundment from failure in the event that the outlets were overtopped.

Figure 2. Reliance No. 11 North geomorphic design using 3D rendering. Two surface water impoundments were utilized for water attenuation.

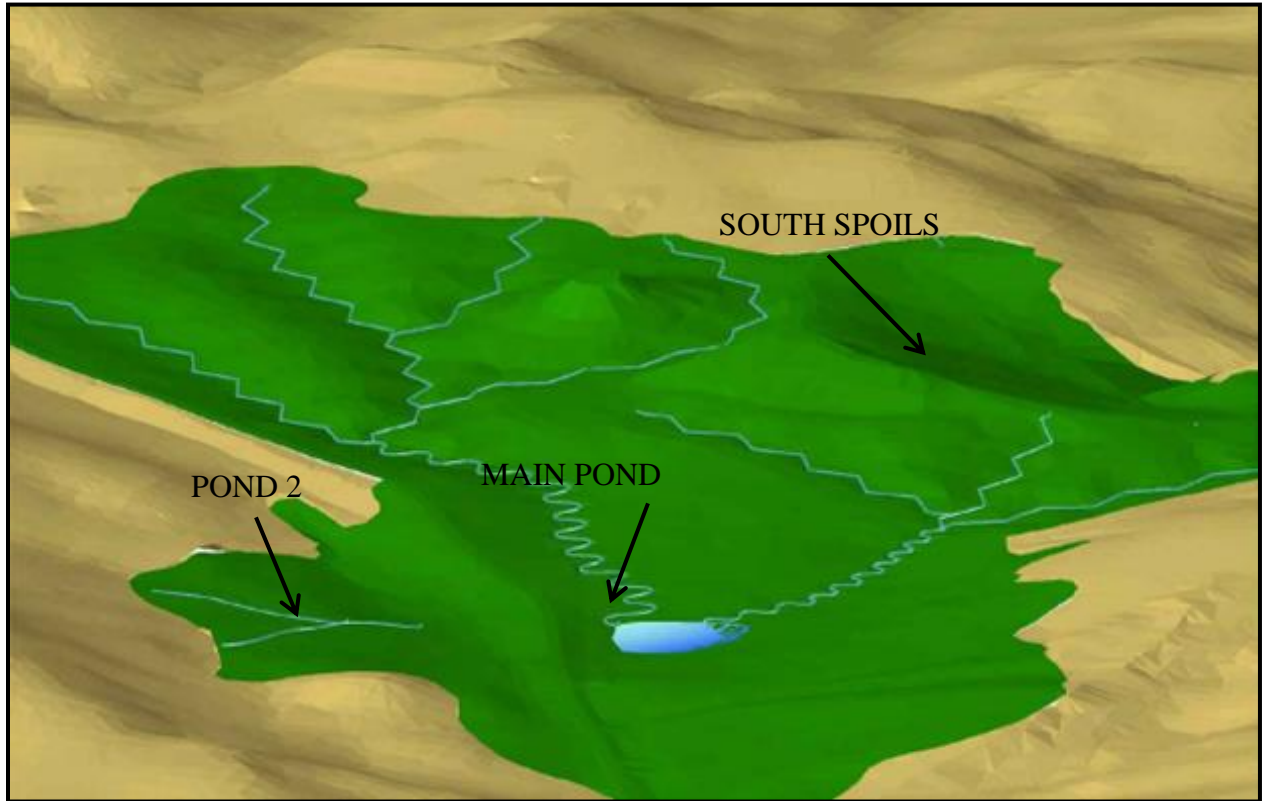
The South Spoils (Fig. 3) was created by mine waste being dozed over the edge of a steep natural escarpment. This resulted in an over-steepened fill slope that covered a steep native drainage of primarily exposed bedrock. The proposed reclamation design entailed excavating this area to approximate pre-mine topography. In practice, only a portion of the design was constructed to grade, as native bedrock was exposed prior to achieving the design grades. The constructed surface was adjusted in the field for exposed bedrock. As such, the geomorphic design parameters were not met, and the design provided only a loose framework for long-term evaluation of the existing surface.

Figure 3. Reliance No. 11 South geomorphic design with 3D rendering. The Main Pond was a pre-existing feature that was retained in the design to trap sediment.

Geomorphic channels within the South Spoils area were found to have been damaged by vehicles, as they had been used as roadways following reclamation. However, the channels were still performing well. Natural bedding of bedrock was observed to be anchoring the channel flow-lines and no unnatural level of erosion was observed to be occurring at the time of inspection, despite the post-reclamation damage to the channels by off-road vehicles. The most active pilot channel formation in the area occurred within a 20-ft channel segment within the South Main geomorphic channel. Following multiple unseasonably heavy rain events during fall 2013, the site was revisited and the original 18-in. deep pilot channel had repaired itself. However, a sub-ridge failure upstream of the same confluence had developed and was cutting 10 to 18 in. deep along a 150-ft long channel reach. The channel segment was repaired in fall 2013 by widening the flow-line and reinforcing the channel banks. This repair is expected to decrease the flow depth within the channel and reduce erosion to an acceptable level. No other repairs were deemed necessary.

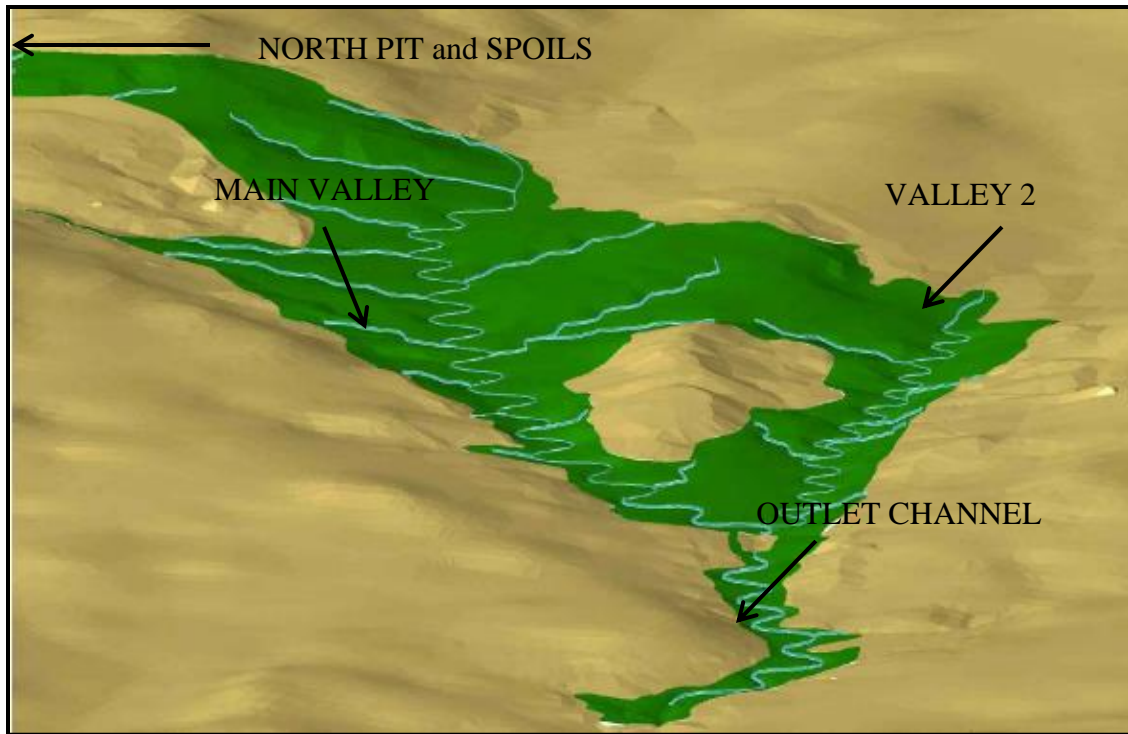
Figure 4. Reliance No. 3 geomorphic design with 3D rendering. The geomorphic design mimicked the natural topography, even though the stability criteria was exceeded.

The basin area for the Main Valley is 223 ac. The Main Valley drainage is over a mile long with approximately 365 ft of relief and 109 ac of contributing area. Fourteen tributary channels are connected to the main channel, with an additional three secondary tributaries adding to the dendritic drainage pattern. Many of these channels exceeded the recommended shear stress values. High shear stresses are primarily related to steep channel gradients, low drainage density, and large contributing areas.

The local basin area for the North Spoils is 4.5 ac. The total contributing area entering the North Spoils basin is 12.9 ac, which includes the North Pit separated by a reach of undisturbed channel. The North Spoils basin is approximately 484 ft long with 54 ft of relief. The channel shear stresses are in excess of the recommended shear ranges due to the contributing basin area (larger flows).

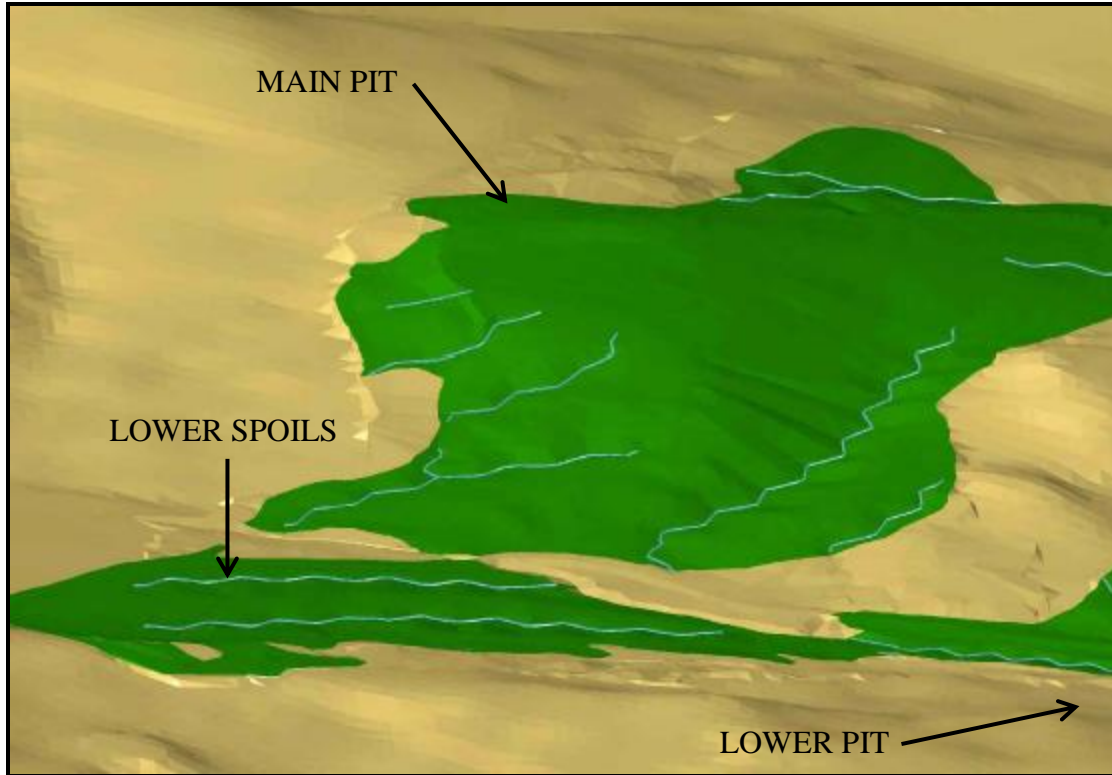
Three separate areas were reclaimed as part the Lionkol Main Pit reclamation portion: The Main Pit, the Lower Pit, and the Lower Spoils (Fig. 5). The Lionkol Main Pit area was a “mountain top strip” type of open pit mine with over-steepened spoils pushed off both the north and south ends of the pit. The reclamation design for this area was modeled as 10 distinct basins due to the upland nature of the site, without connecting channels. The Main Pit is approximately 54 ac, with individual design basins averaging 5.4 ac. The design attempted to reclaim the site to approximate pre-mine contours by removing the spoils that had been dozed off the top of the ridge, and relocating the spoils in the pit (Fig. 6). During the excavation of the spoils, the pre-mine surface was exhumed on both the north and south sides, exposing native sandstone rock outcrops. As a result, three of the channels were not built to the design grades over portions of their alignment. These channels had steep sections of sandstone rock, with the design grades constructed above and below the bedrock sections. Most of the channel shear stress ranges are in excess of the recommended values. For these basins, the high shear stresses are caused by steep channel gradients. However, based on the small average basin size, the total volume of flow is typically low, and as such the erosional ability of the flows is minimal.

Figure 5. Lionkol Main Pits geomorphic design shown with 3D rendering. The design had to be amended to match the native surface, due to sandstone outcrops exposed under the spoils pile.

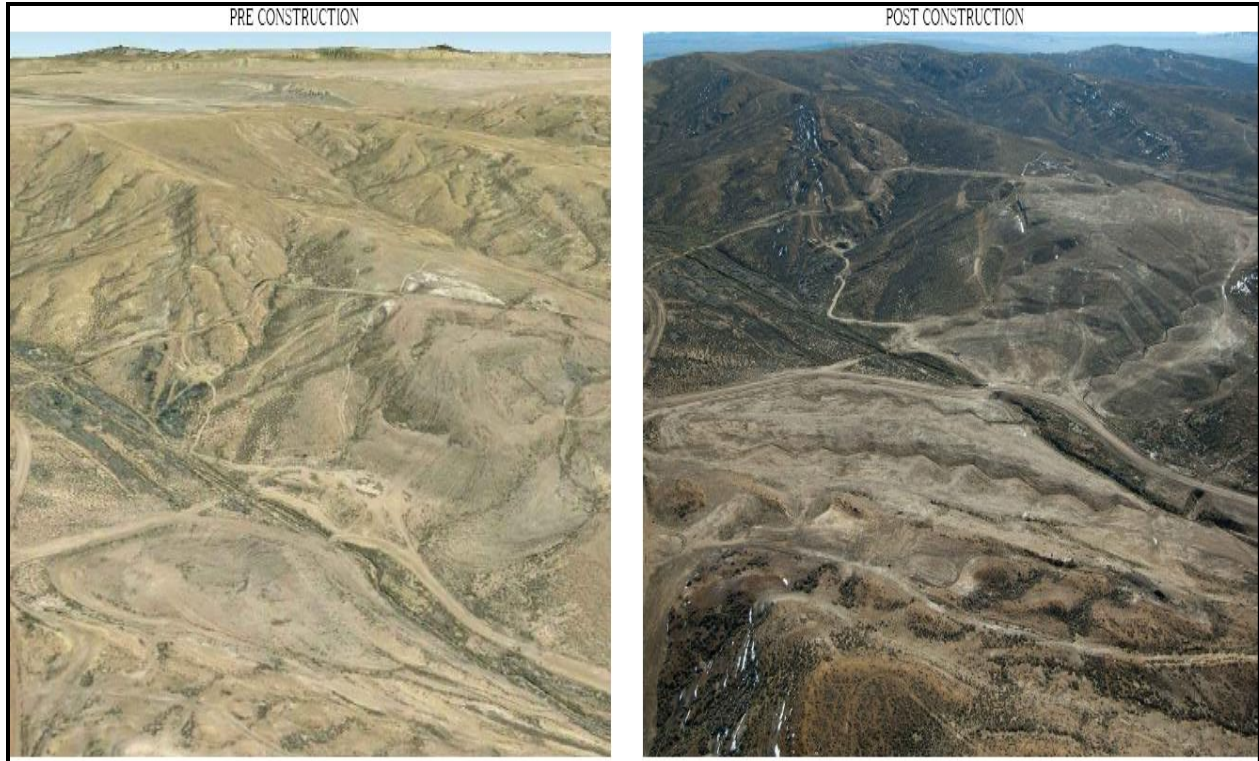
Figure 6. Lionkol Main Pits images before and after construction. The Main Pit was a “mountain top” mine, where the top of the hill was excavated and pushed over the sides.

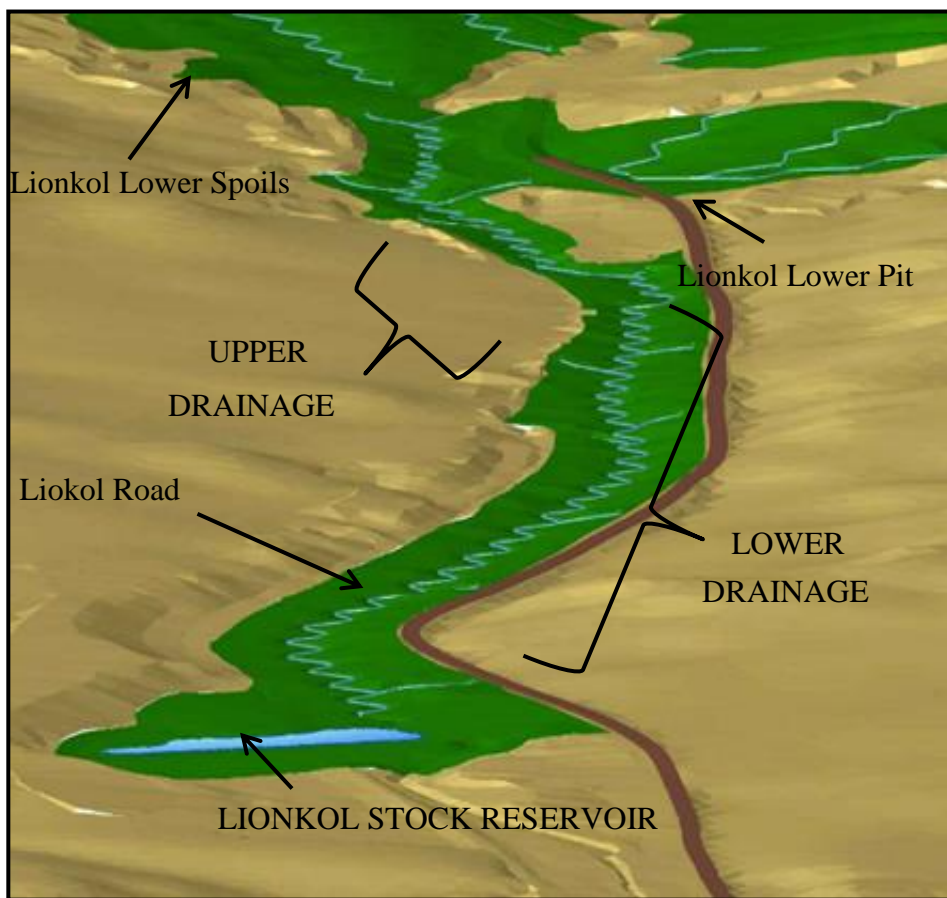
Figure 7. Lionkol drainage design with 3D rendering showing design areas. The project was split into two drainages, to design around cultural features.

Storm flows in the Lionkol drainage in the spring and summer of 2016 surpassed those of the previous years. The Lionkol Stock Reservoir, designed to contain the 100-year storm volume, filled, and the spillway conveyed excess flows. The main channel sustained damage that required repairs, as shown in Fig. 16. Repairs were performed in fall 2016 and included a re-design of the channel where the Upper and Lower drainages meet (Fig. 7). This is an area where two design

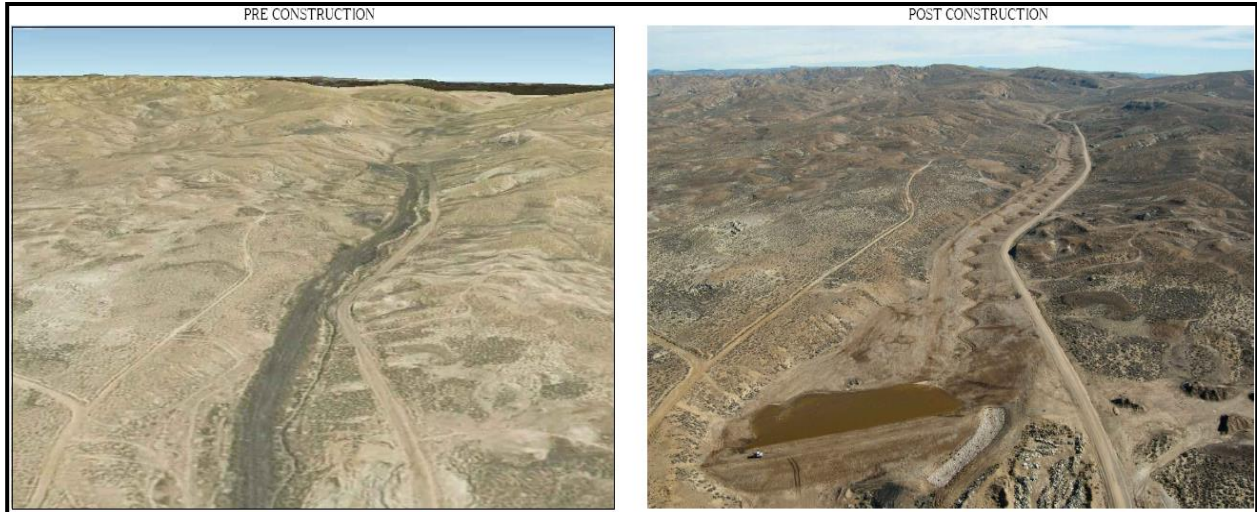
Figure 8. Images of the Lionkol drainage before and after construction. The design channel terminates at the Lionkol Stock Reservoir.

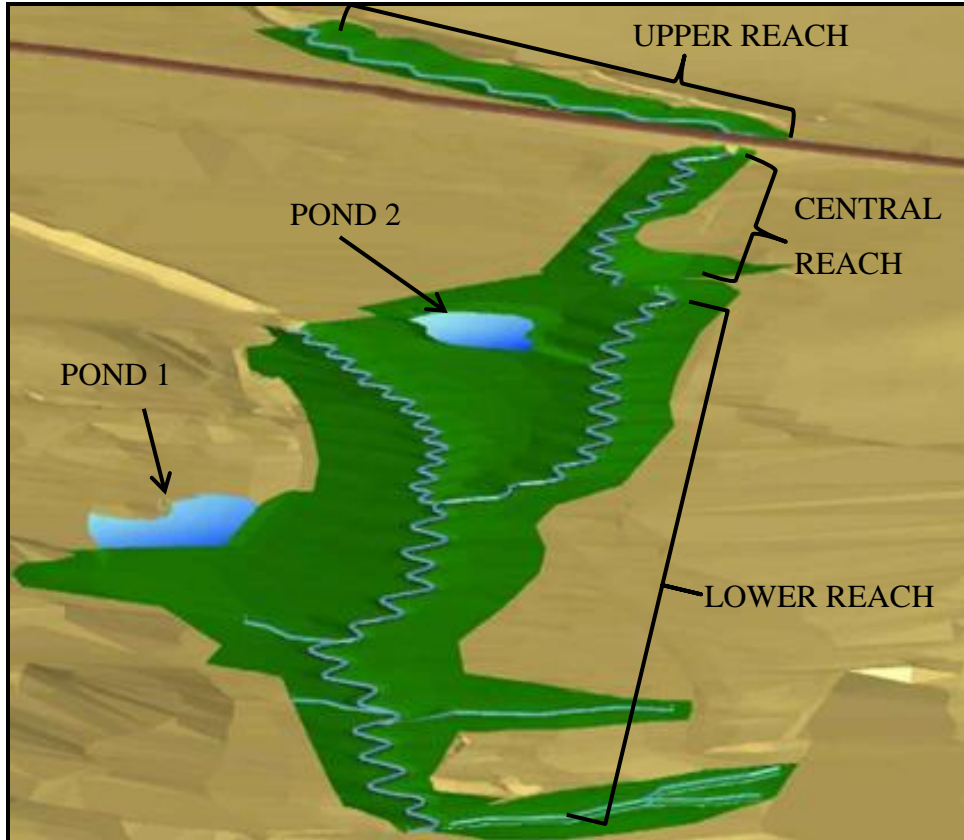
Figure 10. Lionkol West drainage design with 3D rendering. The site was constrained by culverts, so the design was split into three reaches.

A rock structure was added at the confluence of main channels in the Lower Reach (see Fig. 10) to control erosion of the channel banks in this area. Minor repairs were made to some of the

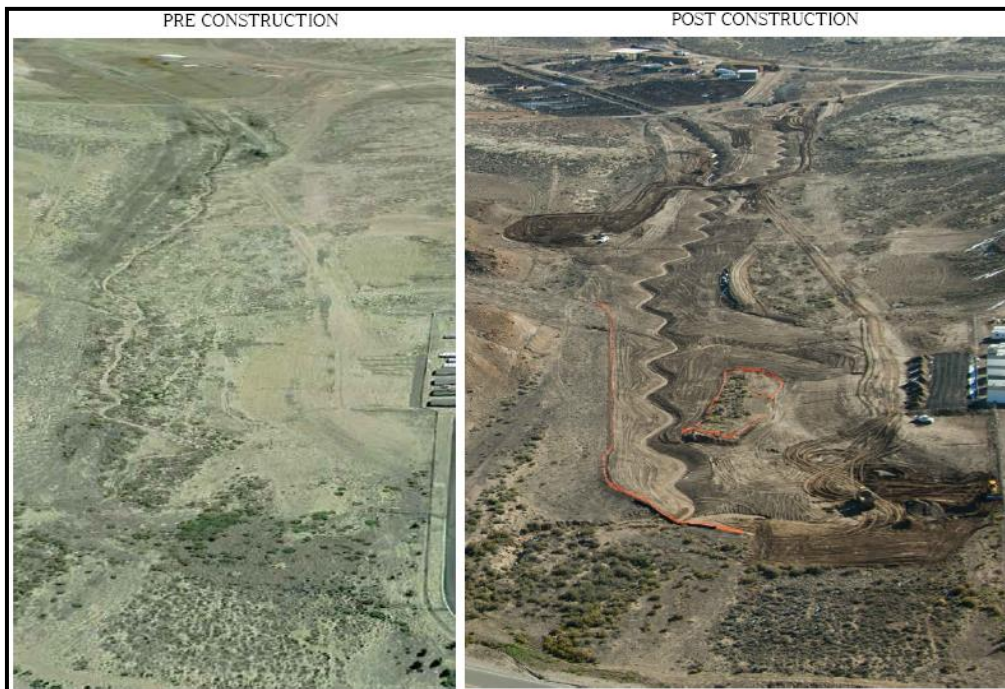
Figure 11. Lionkol West drainage before and during construction. Cultural features and a pipeline were fenced with orange safety fence.
